Victory Minerals

Environmental Review Committee

Quarterly Report

October – December 2024

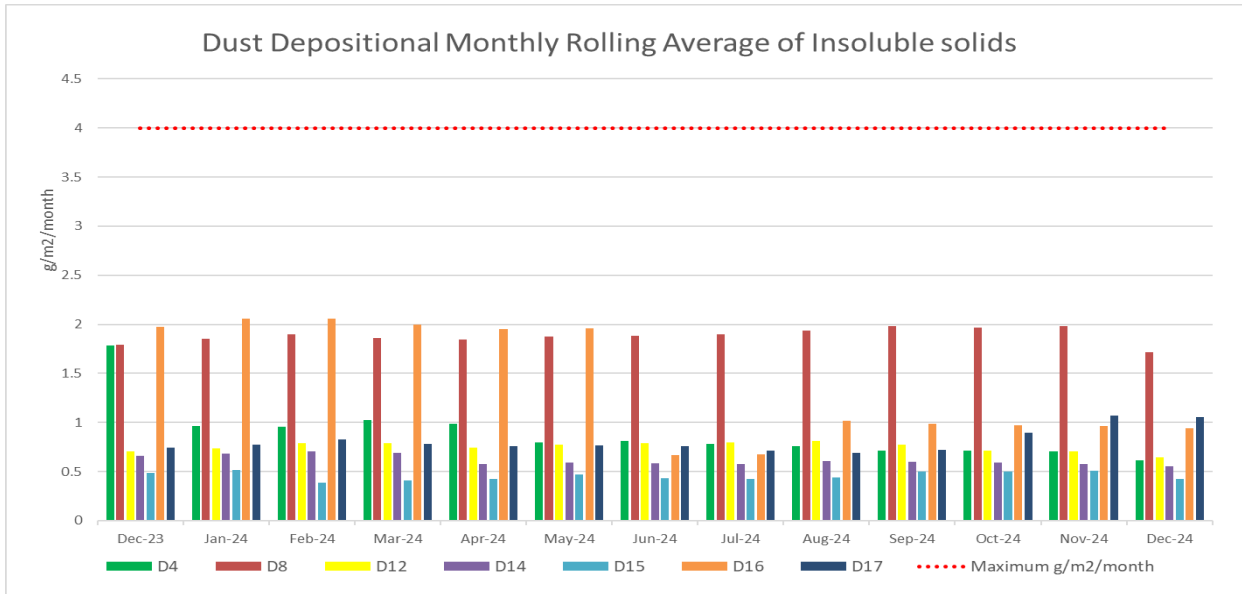
Figure 1- AIR QUALITY COMPLIANCE-INSOLUBLE SOLIDS 12 MONTH ROLLING AVERAGE

All 7 depositional dust monitoring returned results well below monthly maximum threshold limits. Analysis showed insoluble solids ranged from 0.064 to 3.2 g/m²/month (see Figure 1), with regulatory limit of 4.0 g/m²/month. Insoluble solids consist of combustible matter content and ash content; ash represents airborne inert crustal dust, while combustible matter includes fine airborne organic flora such as pollen, seeds, and leaf matter.

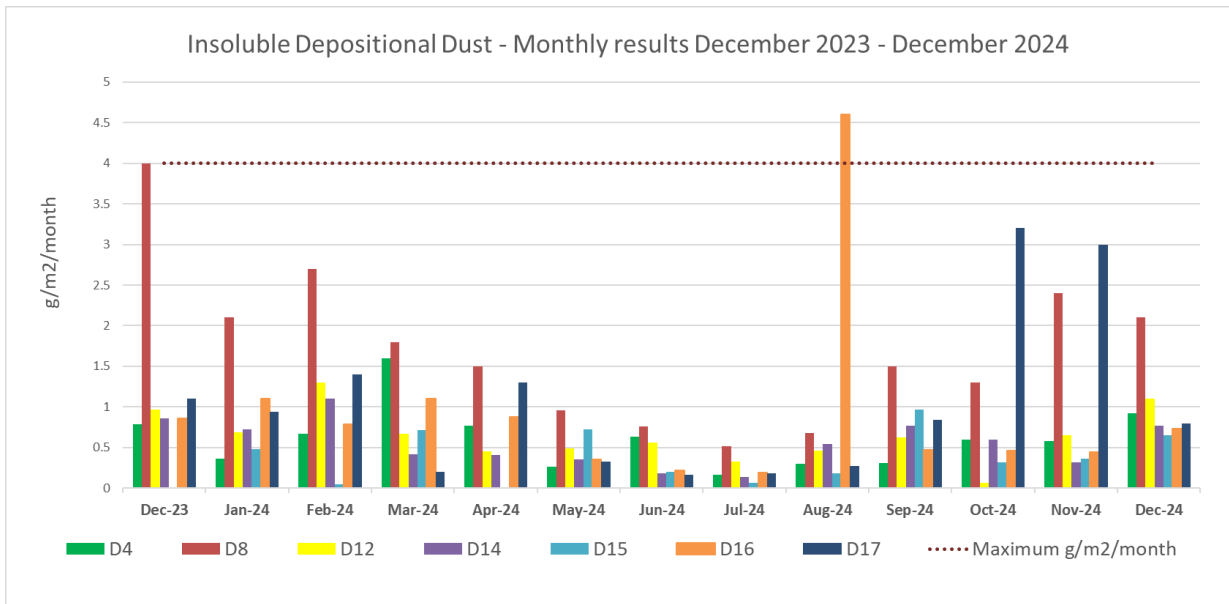
Figure 2 - INSOLUBLE SOLIDS MONTHLY DATA.

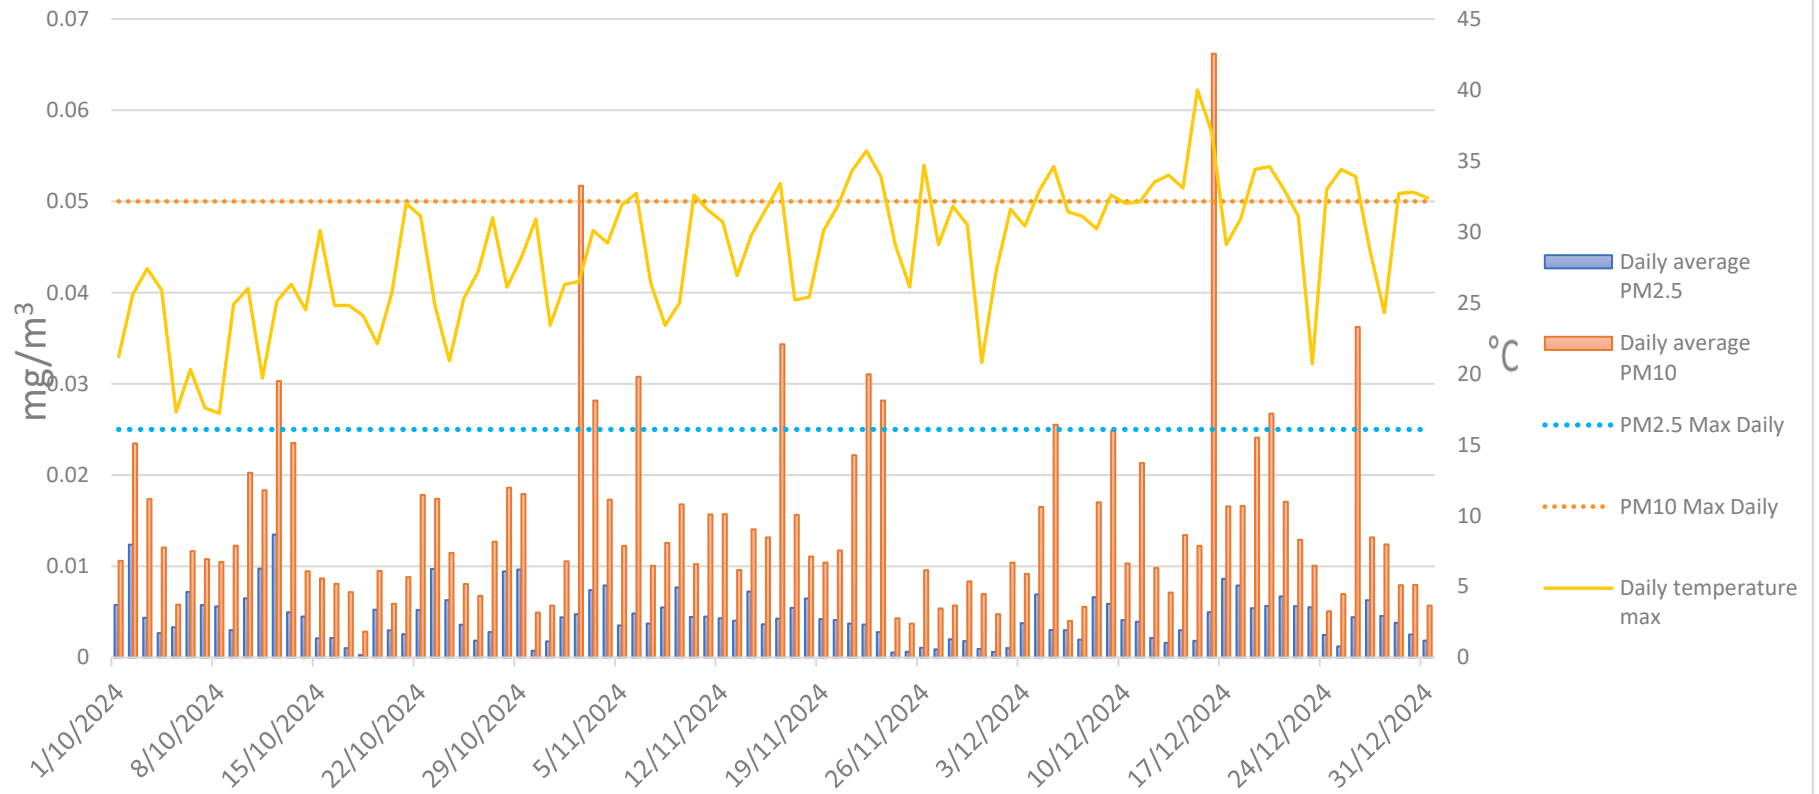
Figure 3 - Ambient air continuous monitoring - White Horse Gully Monitor 1

One Exceedance was recorded for the quarter. On December 16, an exceedance of the PM10 daily average limit was recorded at Monitor 1 (Whitehorse Gully), measuring 0.066 mg/m³, surpassing the regulatory threshold of 0.05 mg/m³. This occurred during a Total Fire Ban across the region, with extreme weather conditions including temperatures reaching 37°C and maximum wind speeds of 91 km/h within the gully.

Given the prevailing N-NE winds, PM10 levels were elevated across the site, with our secondary monitor positioned at the northern end of the site recording 0.0437 mg/m³, indicating airborne particulates moving laterally from external sources before traveling across site. All dust suppression measures were actively in place, and operational adjustments were made as far as reasonably practicable (SFARP), including reducing works, deploying additional water carts, and strategically timing sprinkler use to minimise airborne dust from working surfaces.

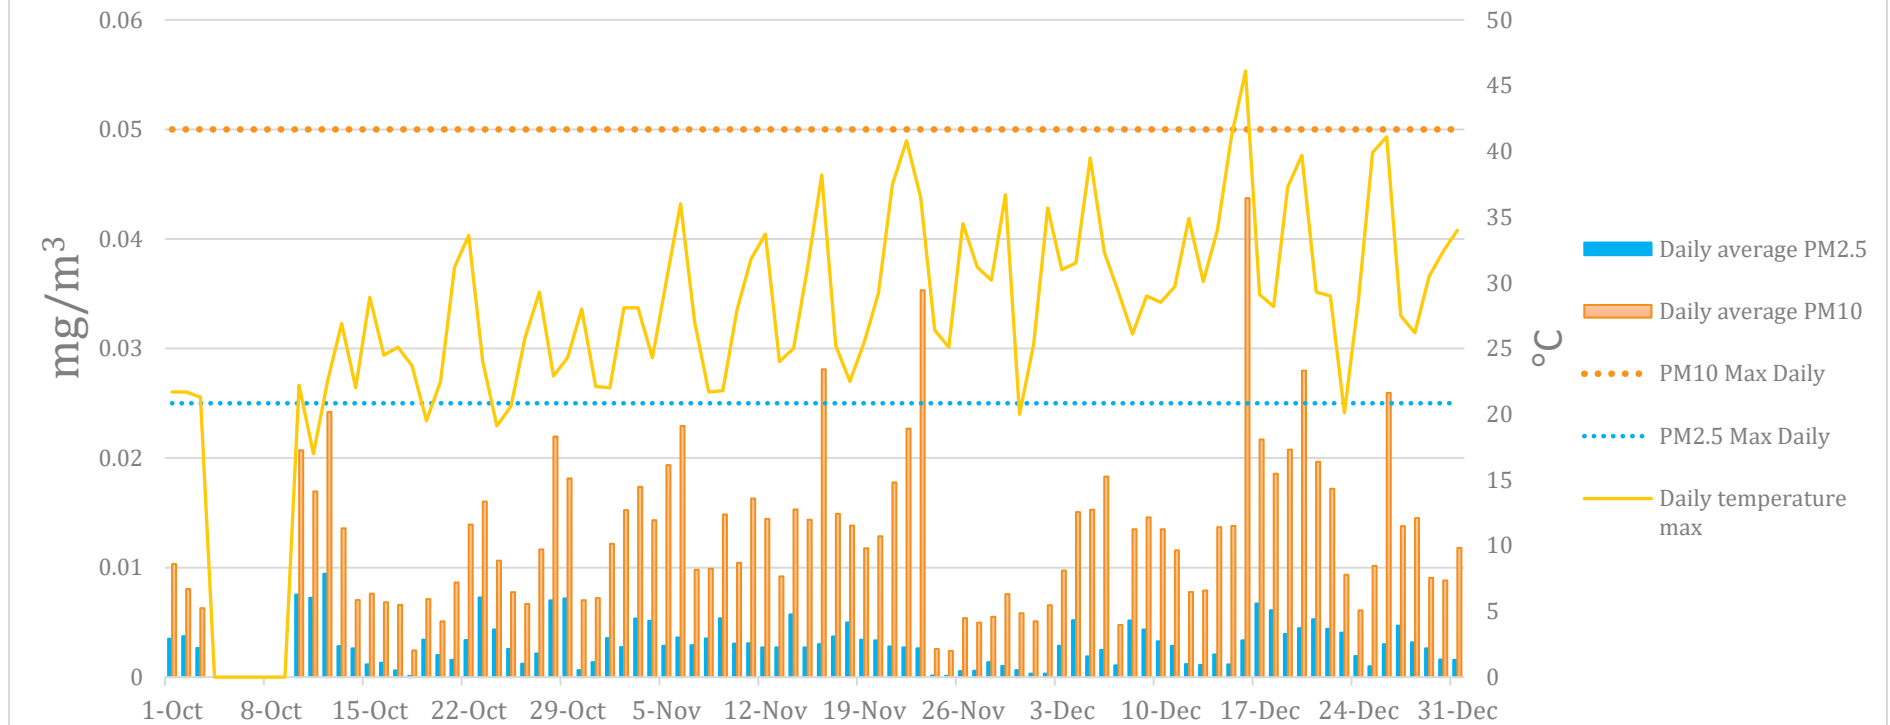
Figure 4 - Ambient air continuous monitoring – Noise bund Monitor 2

Monitor 1, is in place at White Horse Gully and Monitor 2, located at the northern end of the site Near to the Waste rock bund.

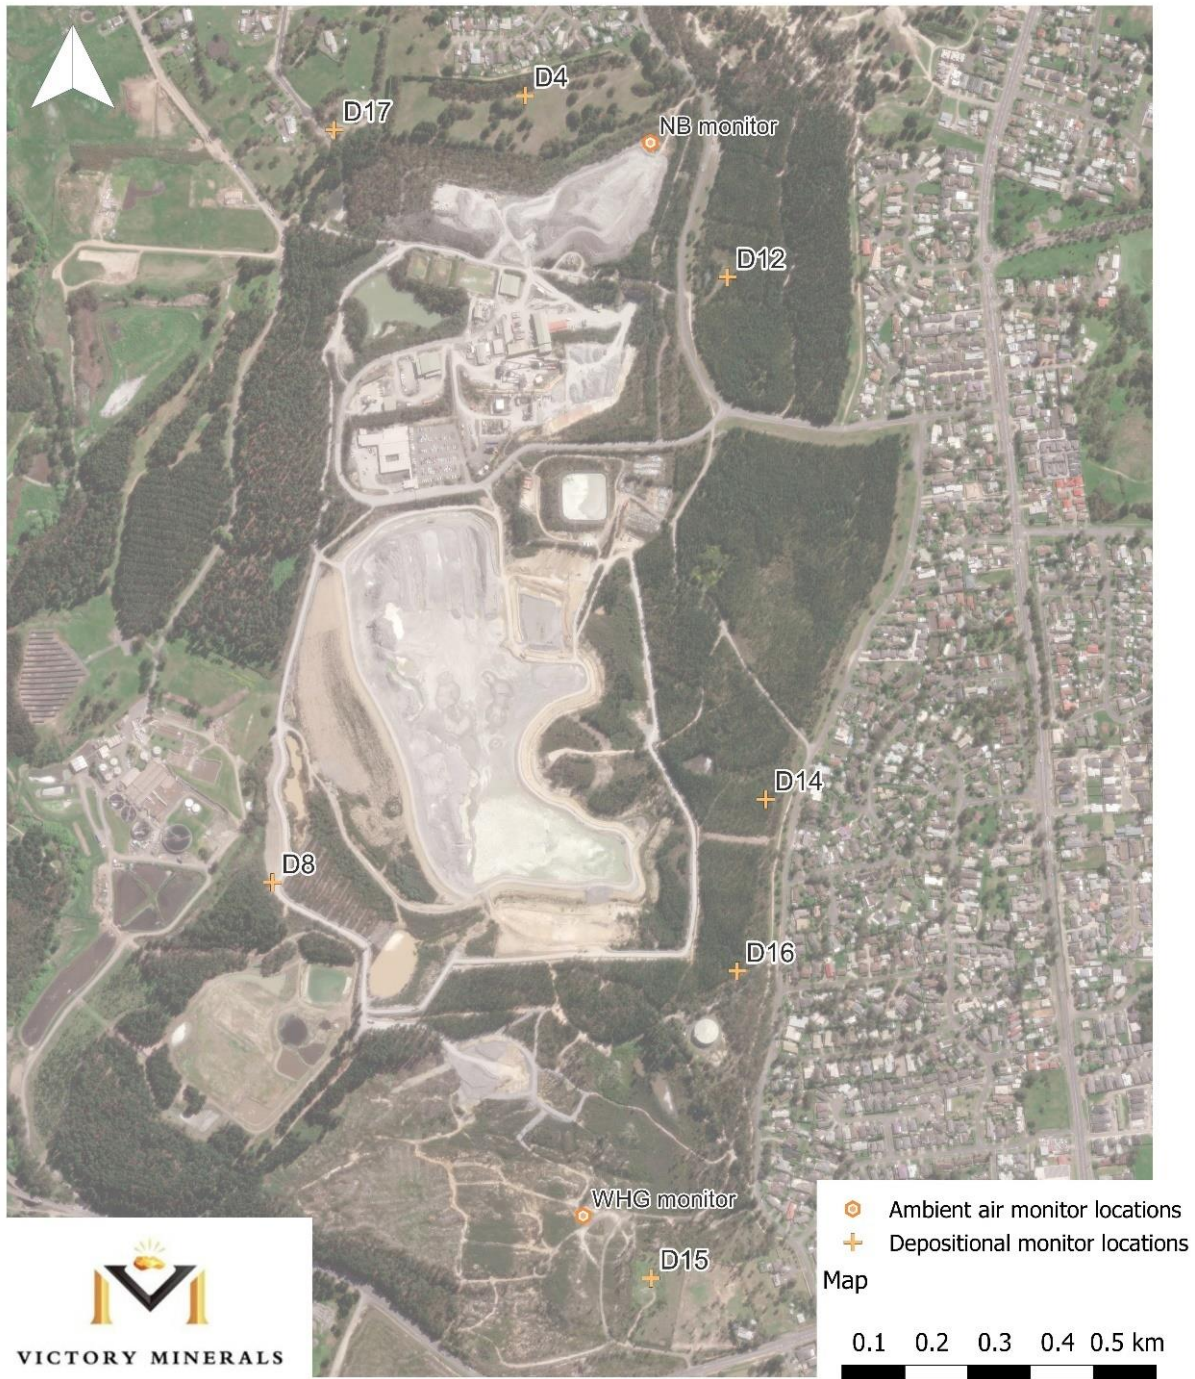
Figure 5 - MAP OF DUST MONITORING LOCATIONS

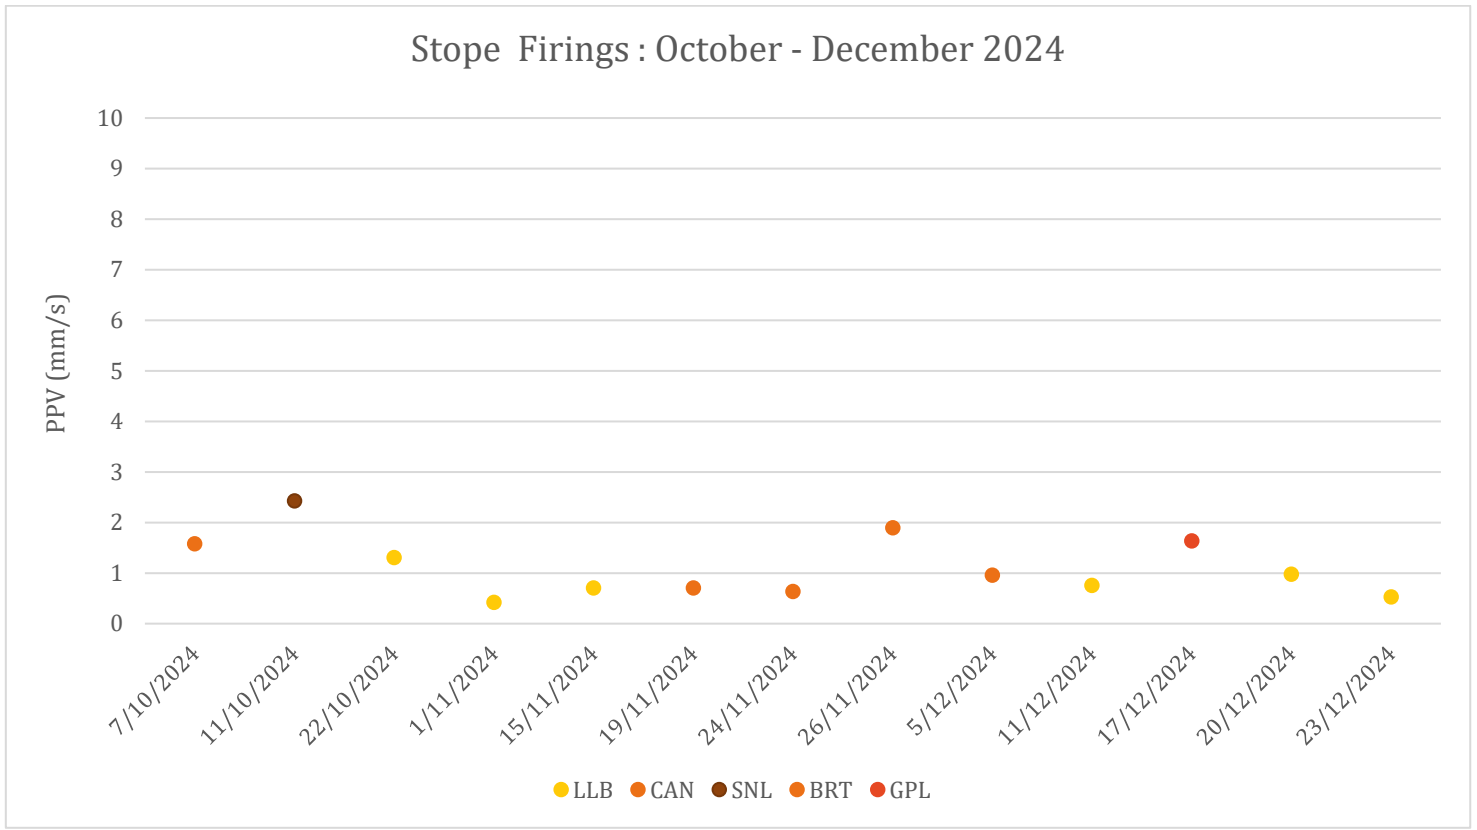
Figure 6 - PRODUCTION STOPE FIRINGS (MAXIMUM VIBRATION FOR EACH FIRING)

Blasting compliance requires 95% of firings to be below 5mm/s. 0 firings out of the 275 exceeded the 5mm/s. The highest recorded ground vibration occurred on 13th of Oct. Following a Stope Firing in the Llanberris compartment measuring 2.79mm/s PPV. Well under the regulatory requirement of 5mm/sec for 95% of blasts

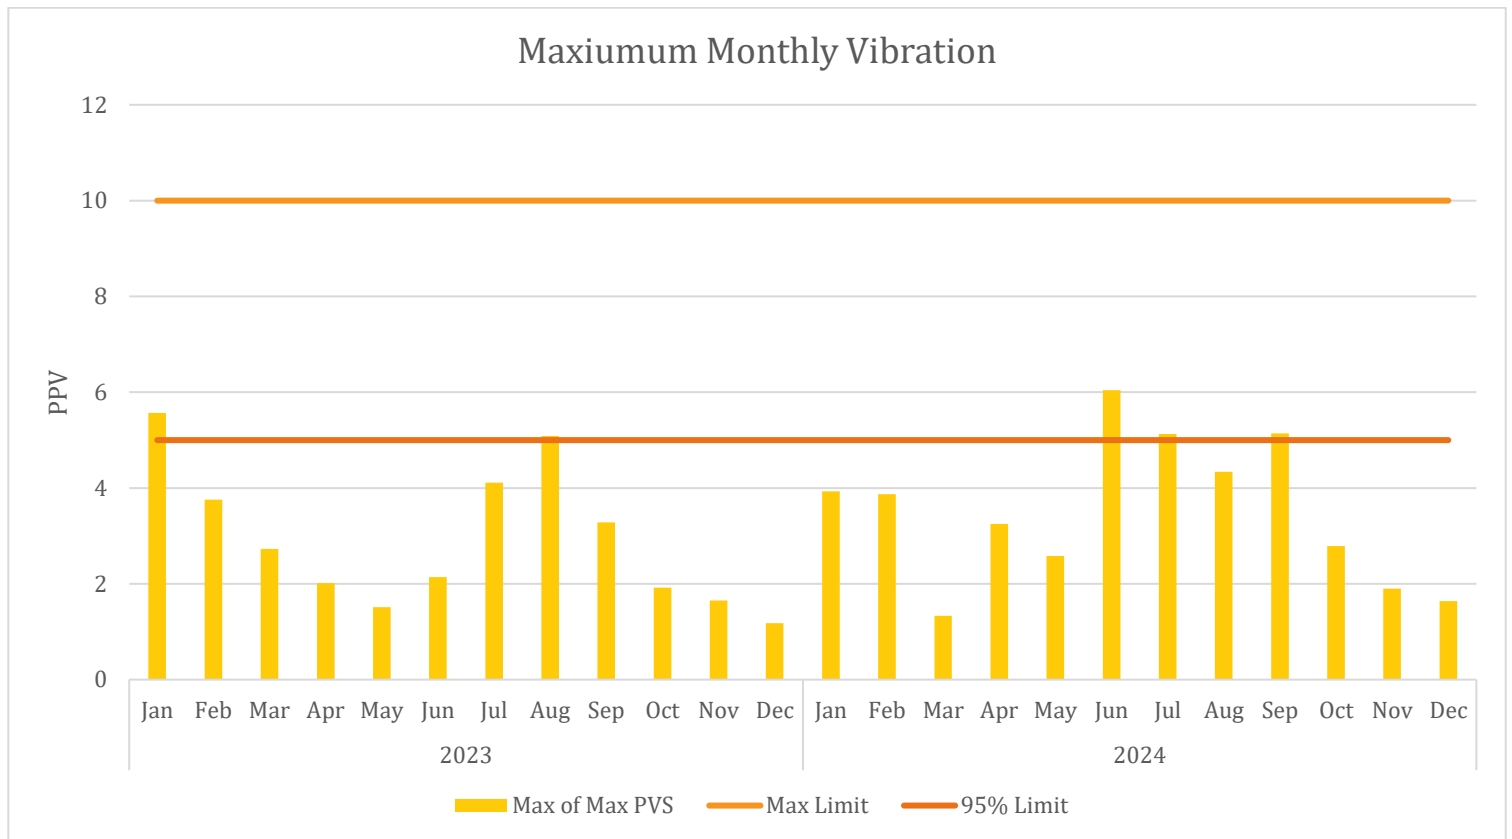
Figure 7 - PRODUCTION STOPE FIRINGS TREND (MONTHLY MAXIMUM AND AVERAGE VIBRATION)

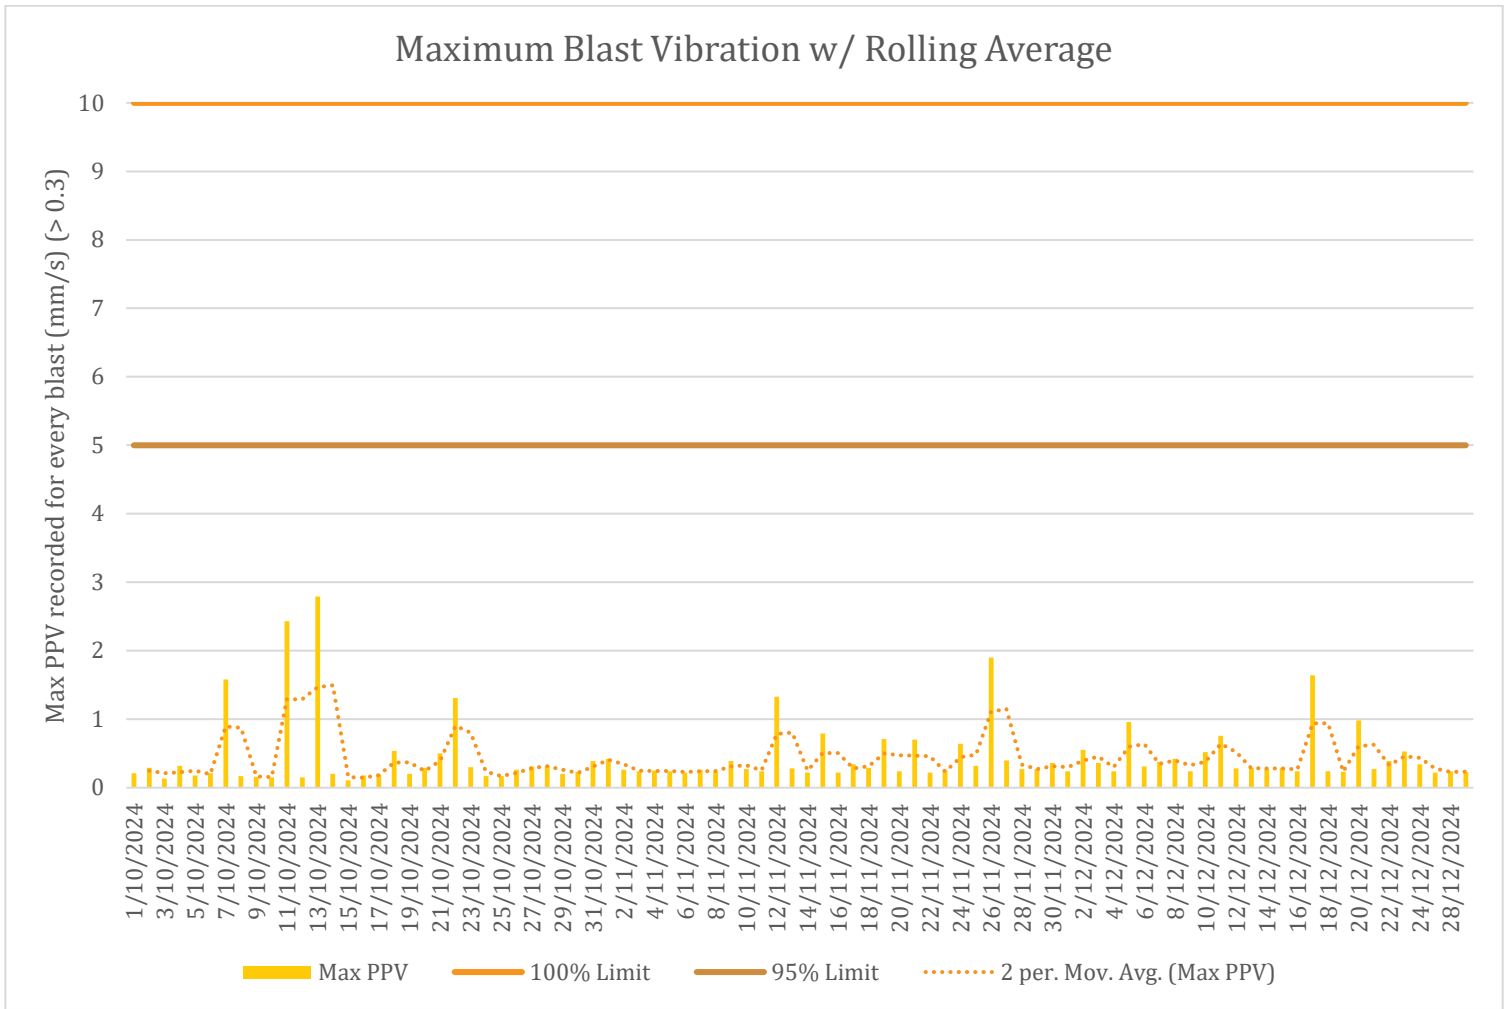
Figure 8 - ALL FIRINGS TREND (MONTHLY MAXIMUM AND APPROX MONTHLY MOVING AVERAGE)

The quarterly rolling average for blast vibration is 0.292mm/s PPV and continues to remain below 1.0 PPV for the year. Victory Minerals continues to employ techniques with the aim to reduce the amount of explosive required where it is practicable.

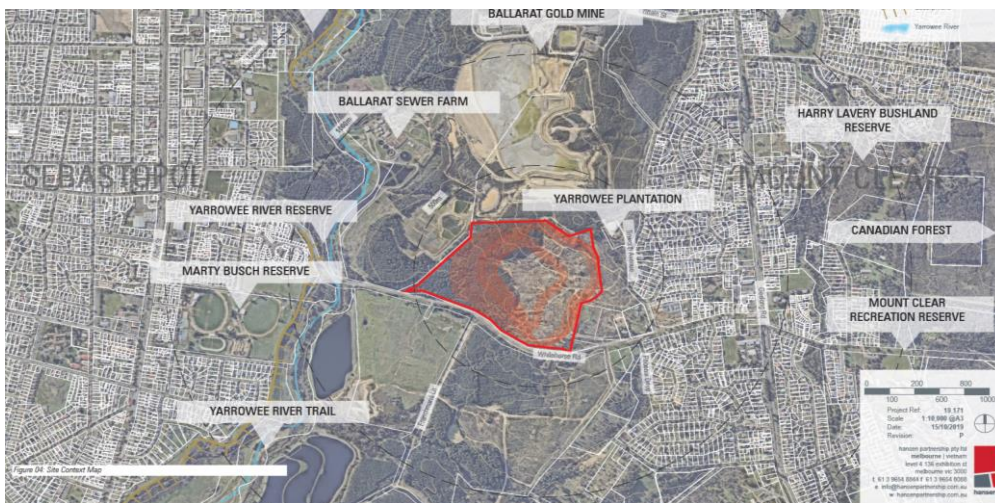
Figure 10 - Location of proposed tailings storage facility in Whitehorse Gully

The conceptual Whitehorse Gully TSF Work Plan Variation (WPV) was endorsed by Earth Resources Regulation and submitted to the City of Ballarat on August 26, 2022. Victory Minerals has continued to work on the TSF4 project this quarter. The TSF4 facility represents the most practical approach for ensuring safe, environmentally friendly, and cost-efficient gold production at the Ballarat site. During the quarter the VCAT tribunal handed down their decision and chose to uphold Ballarat City Councils decision to grant a permit for the facility.

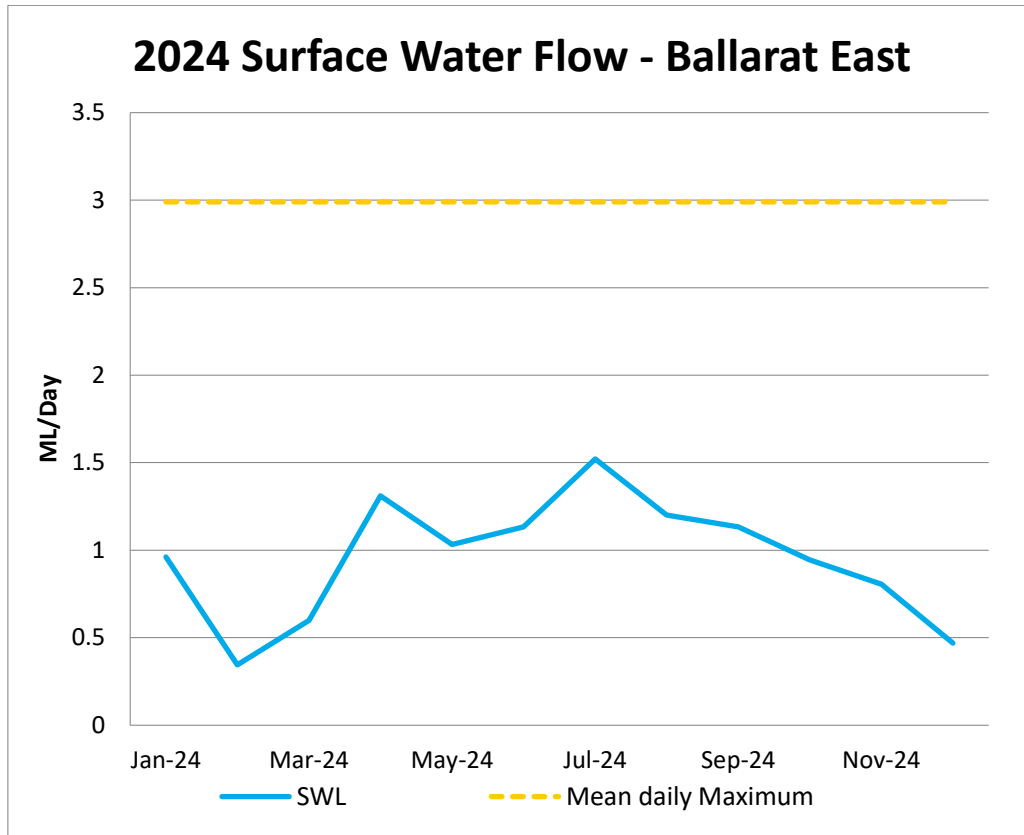
Figure 11 - FLOW RATE SWL EPA DISCHARGE POINT

Located on the northwest side of the property (see Figure 9), the SWL maintained an average daily discharge of 0.747 ML per day, totalling 67.99 ML for the quarter. This remains well below the EPA-licensed discharge limit of 2.9 ML per day.

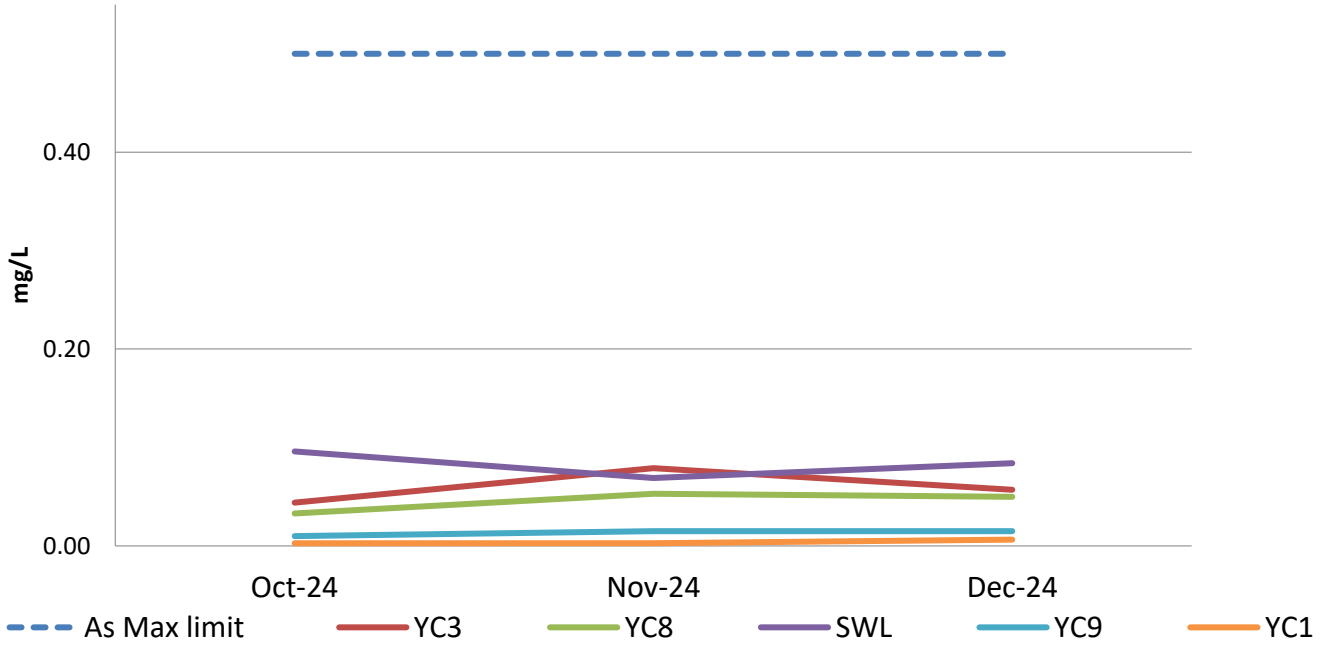
Figure 12 - Arsenic at YC3 & YC8 (upstream), SWL (discharge point) and YC9 (end of mixing zone).

This quarter, all but one Yarrowee monitoring point remained within licensed discharge limits (see Table 6 and Figures 11-20). December testing at YC1 recorded elevated manganese levels, coinciding with low to stagnant river flow. All other parameters returned results consistent with Victory Minerals’ historical data.

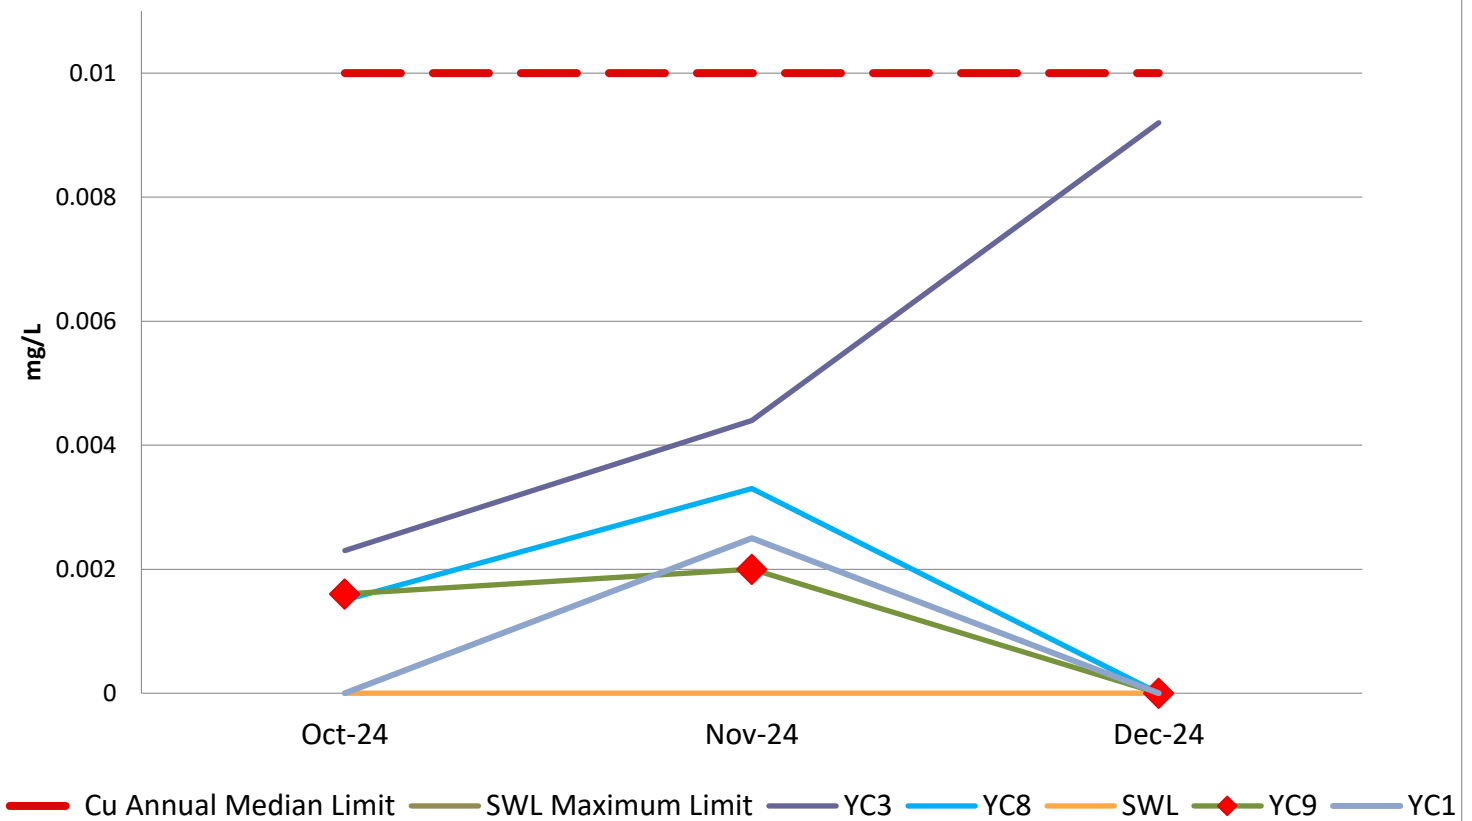
Figure 13 - COPPER AT YC3 & YC8 (UPSTREAM), SWL (DISCHARGE POINT) AND YC9 (END OF MIXING ZONE)

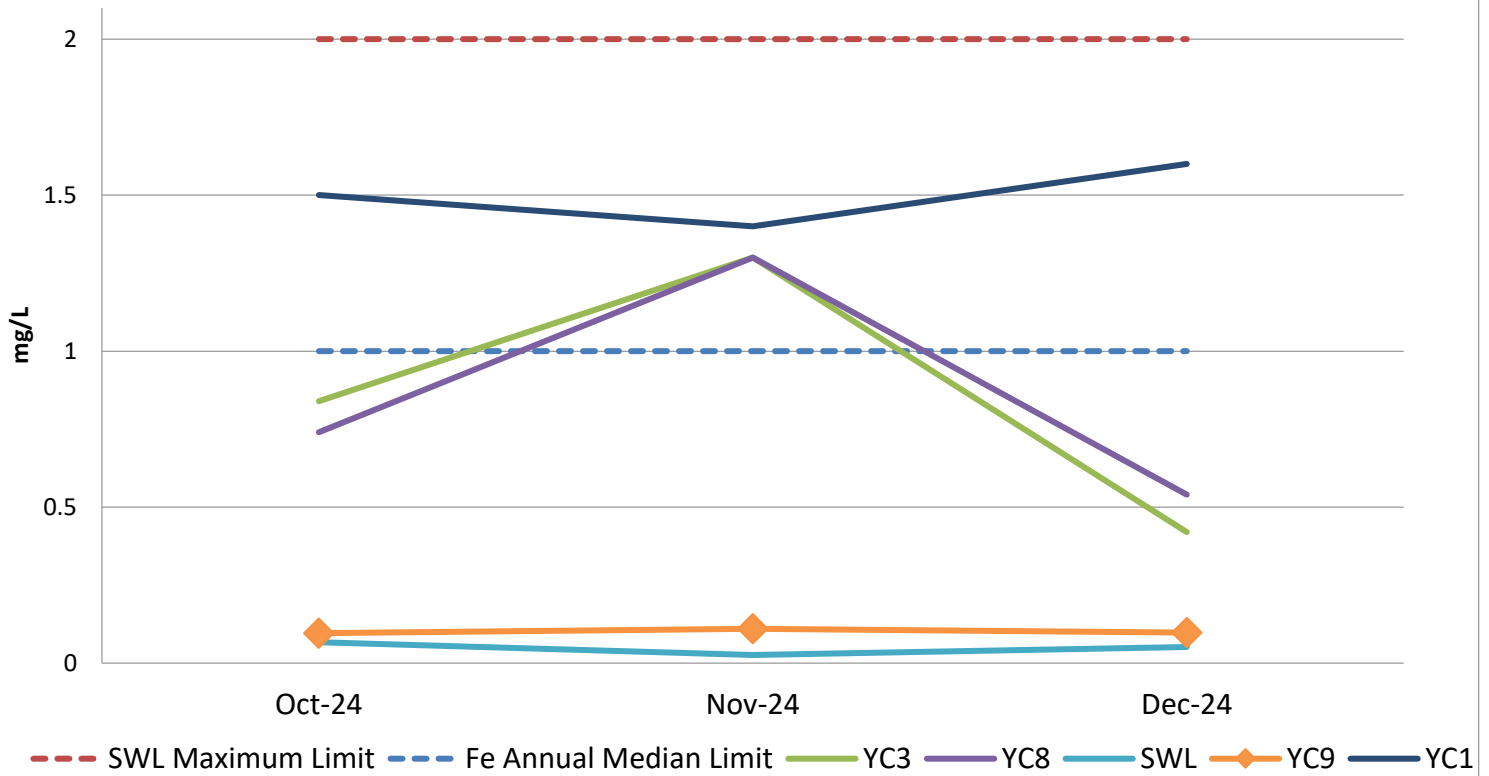
Figure 14 - IRON AT YC3 & YC8 (UPSTREAM), SWL (DISCHARGE POINT) AND YC9 (END OF MIXING ZONE)

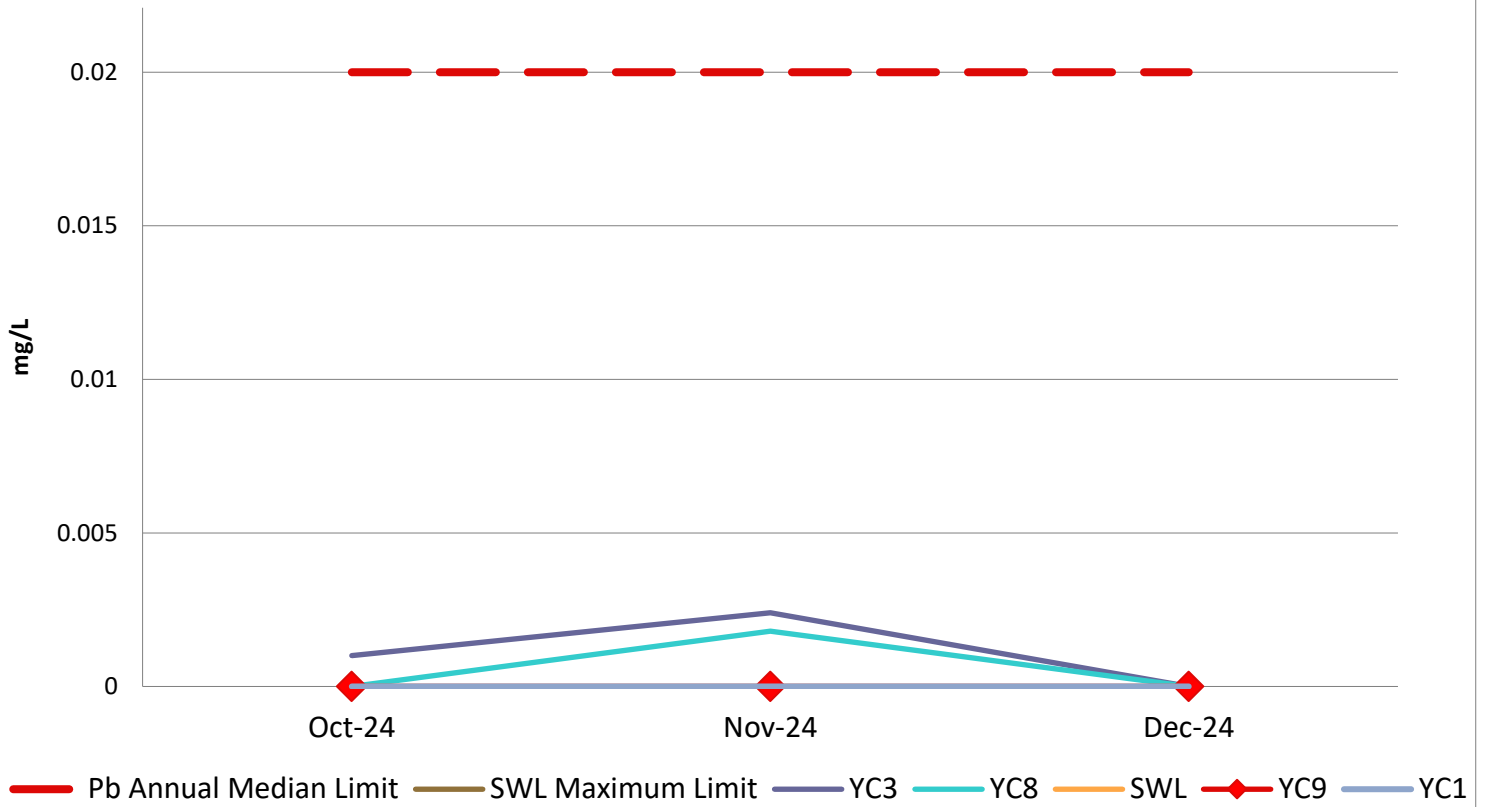
Figure 15 - LEAD AT YC3 & YC8 (UPSTREAM), SWL (DISCHARGE POINT) AND YC9 (END OF MIXING ZONE)

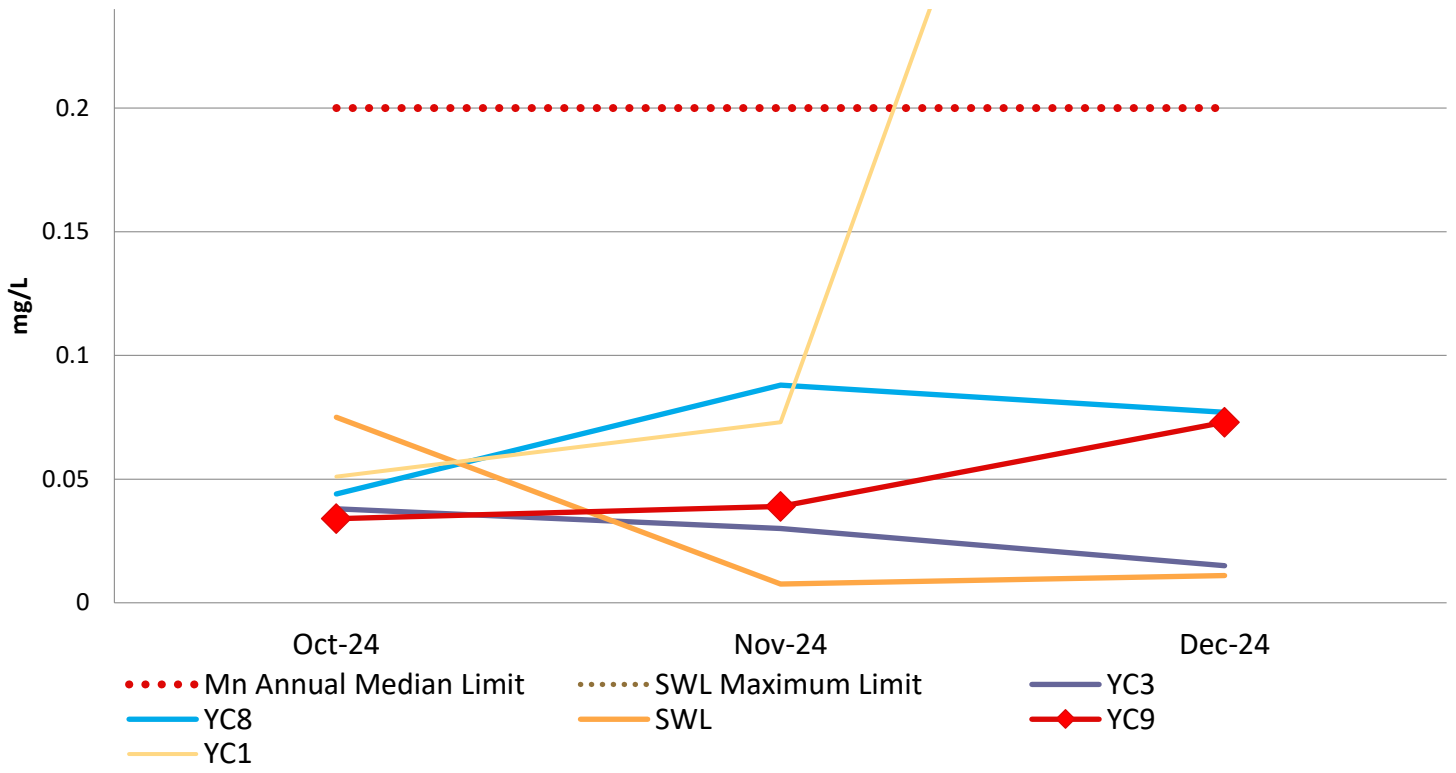
Figure 16 - MANGANESE AT YC3 & YC8 (UPSTREAM), SWL (DISCHARGE POINT) AND YC9 (END OF MIXING ZONE)

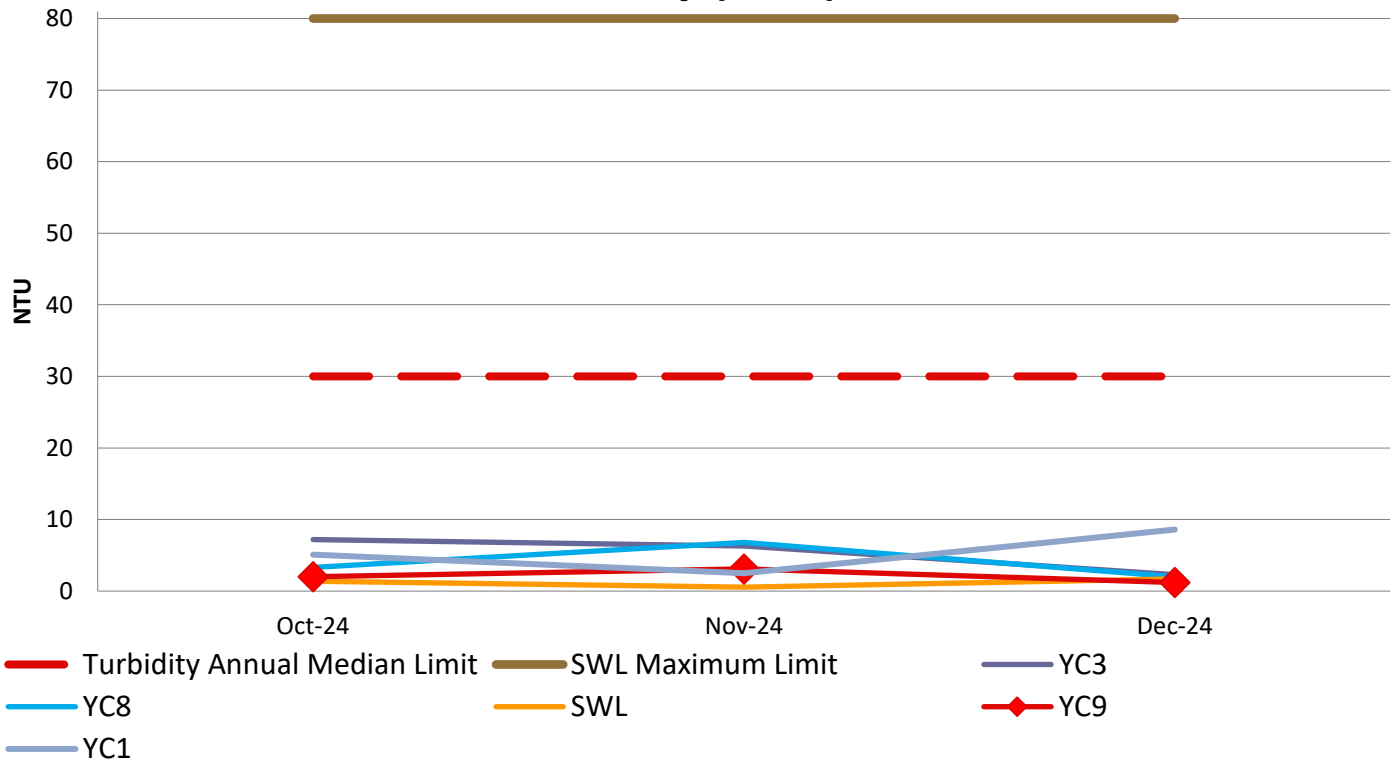
Figure 17 - TURBIDITY AT YC8 (UPSTREAM), SWL (DISCHARGE POINT) AND YC9 (END OF MIXING ZONE)

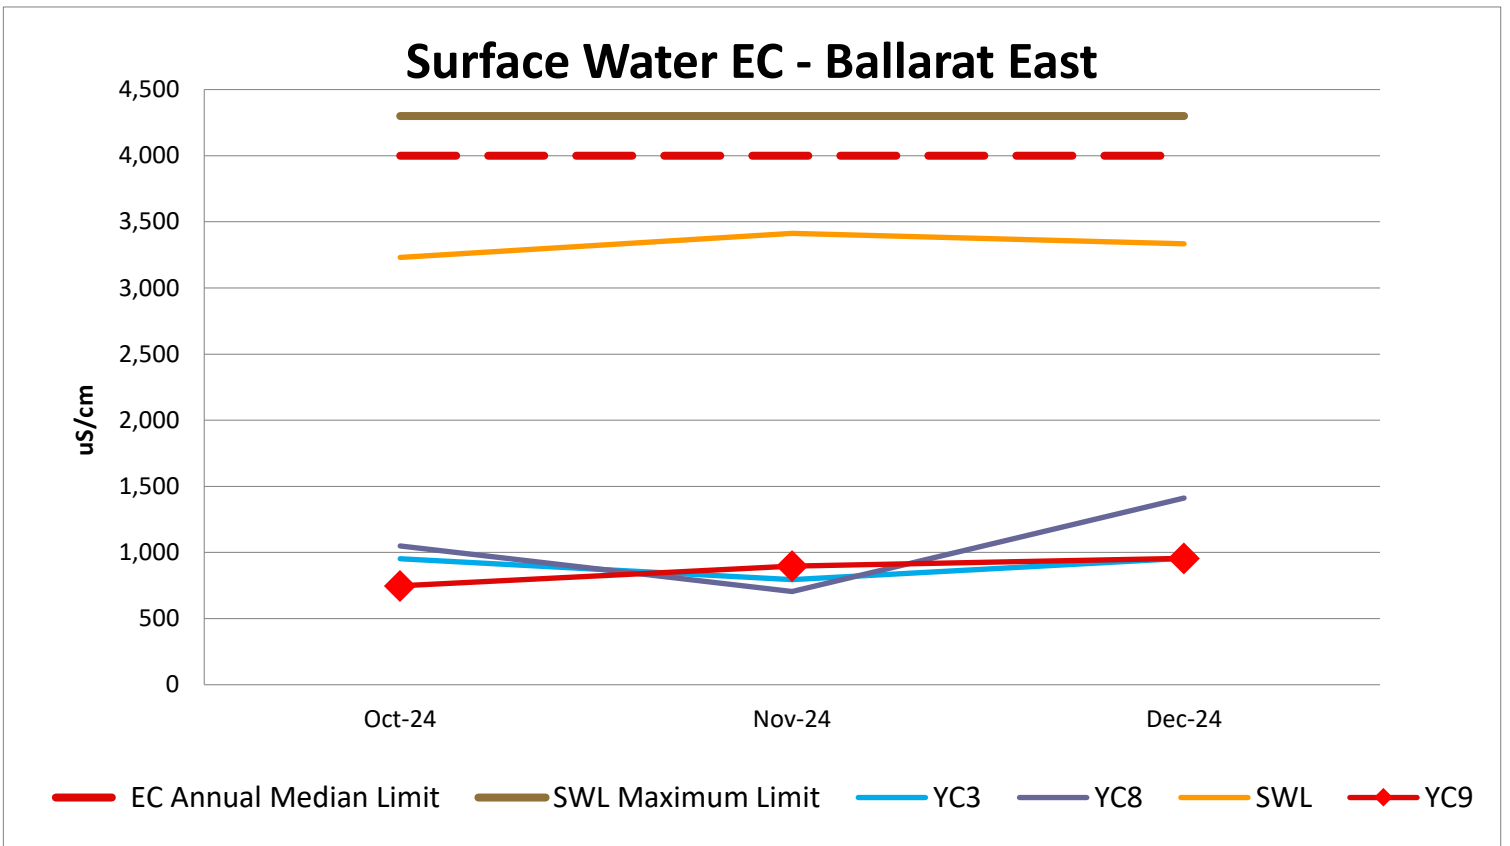
Figure 18 - Electrical Conductivity at YC8 (upstream), SWL (discharge point) and YC9 (end of mixing zone)

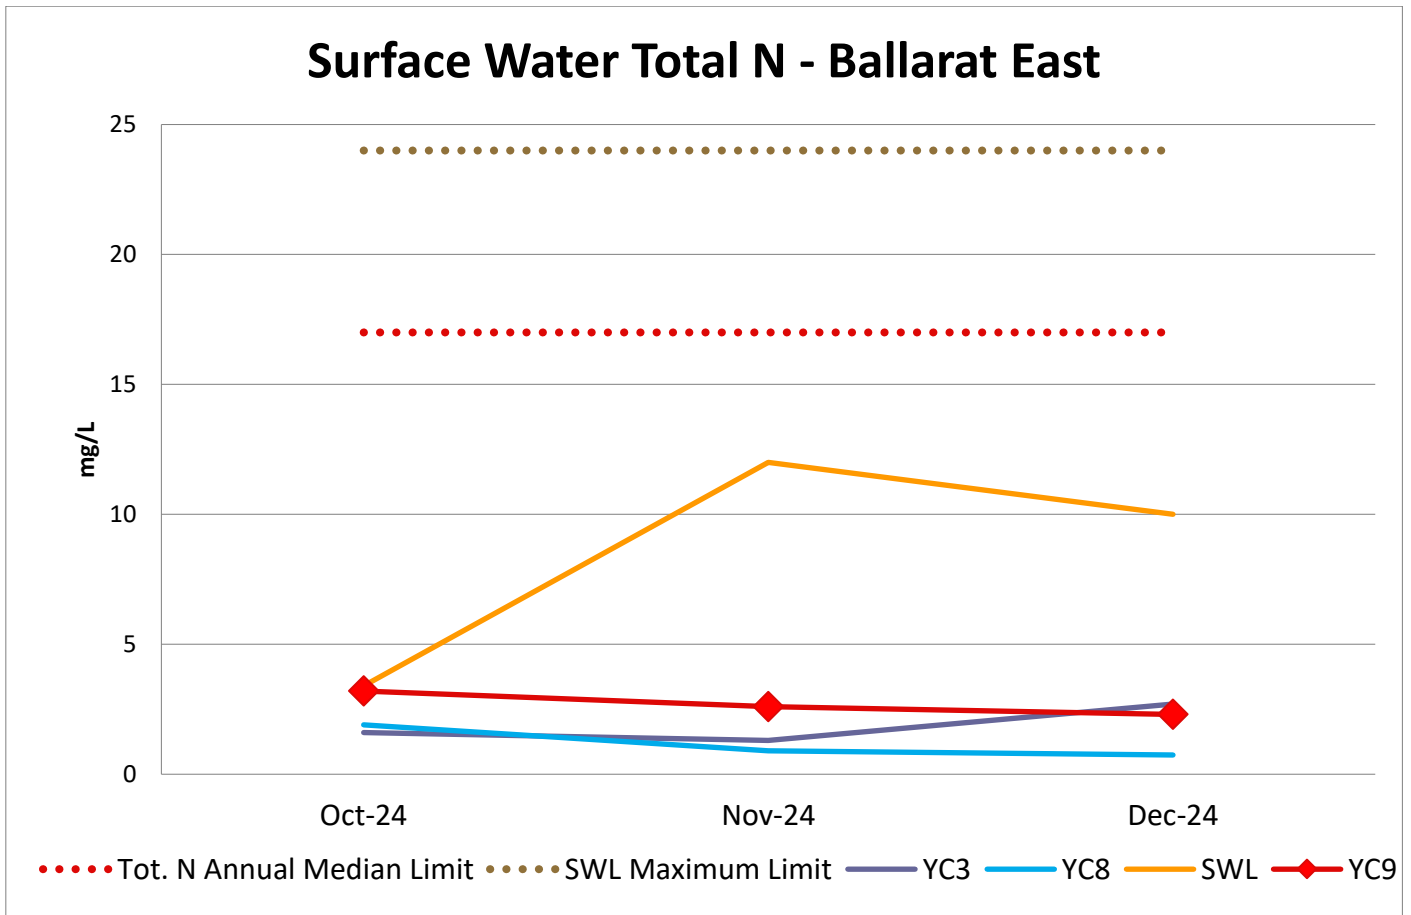
Figure 19 - NITROGEN AT YC8 (UPSTREAM), SWL (DISCHARGE POINT) AND YC9 (END OF MIXING ZONE)

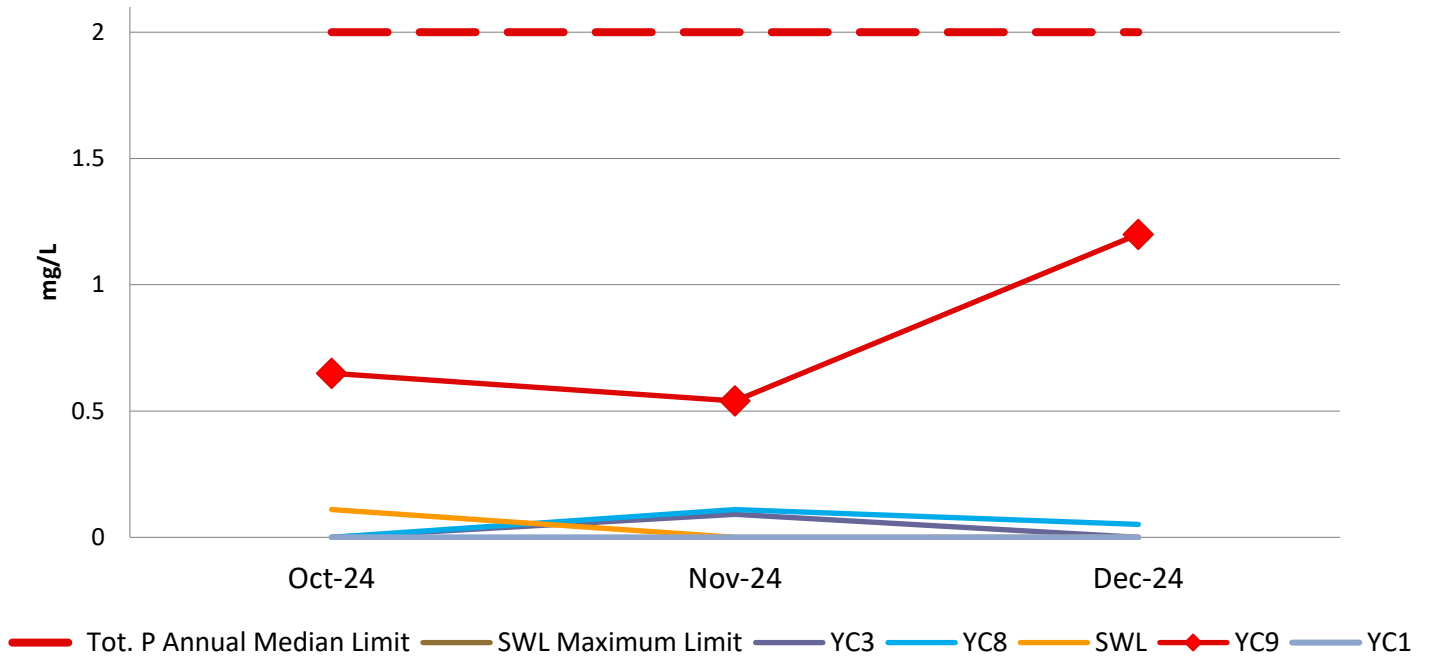
Figure 20 - PHOSPHORUS AT YC8 (UPSTREAM), SWL (DISCHARGE POINT) AND YC9 (END OF MIXING ZONE)
