Victory Minerals

Environmental Review Committee

Quarterly Report

October – December 2024

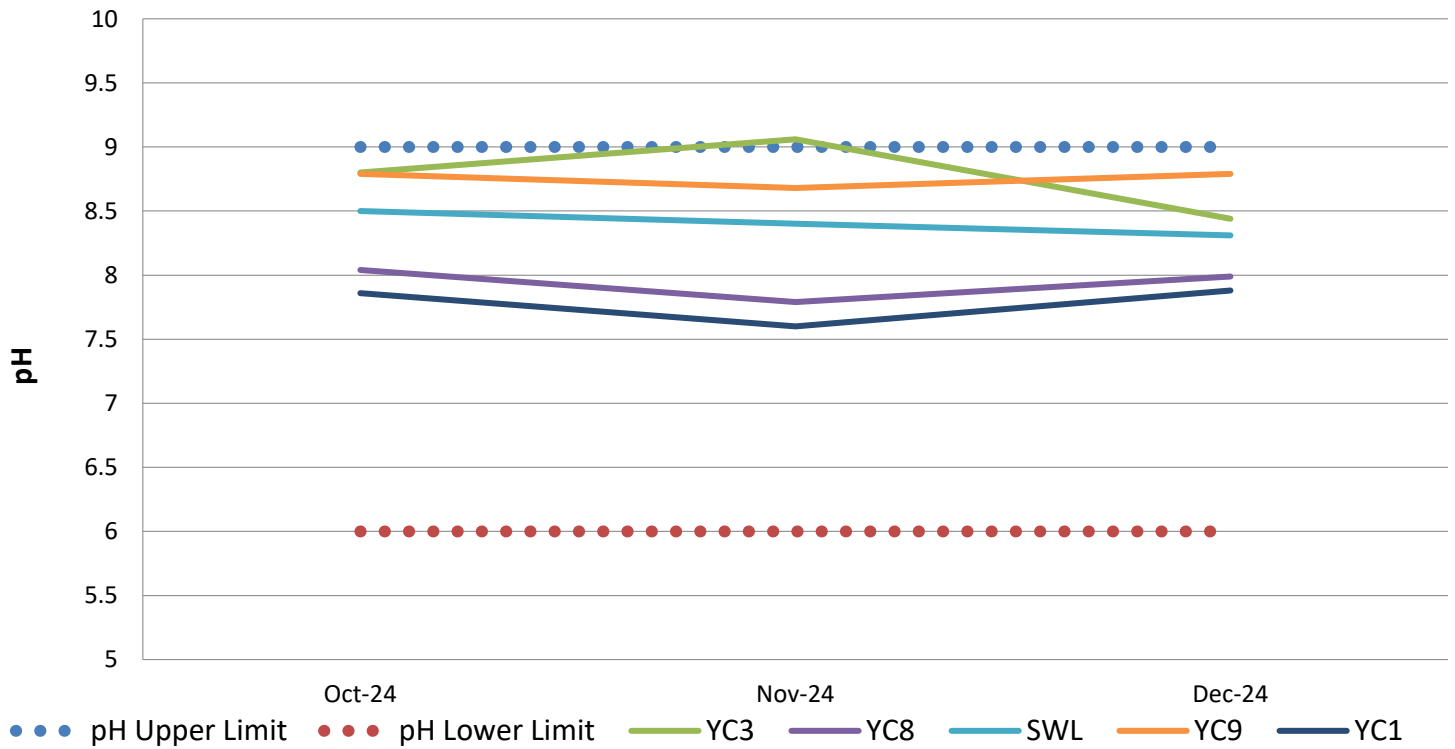
Figure 21 - PH AT YC8 (UPSTREAM), SWL (DISCHARGE POINT) AND YC9 (END OF MIXING ZONE)

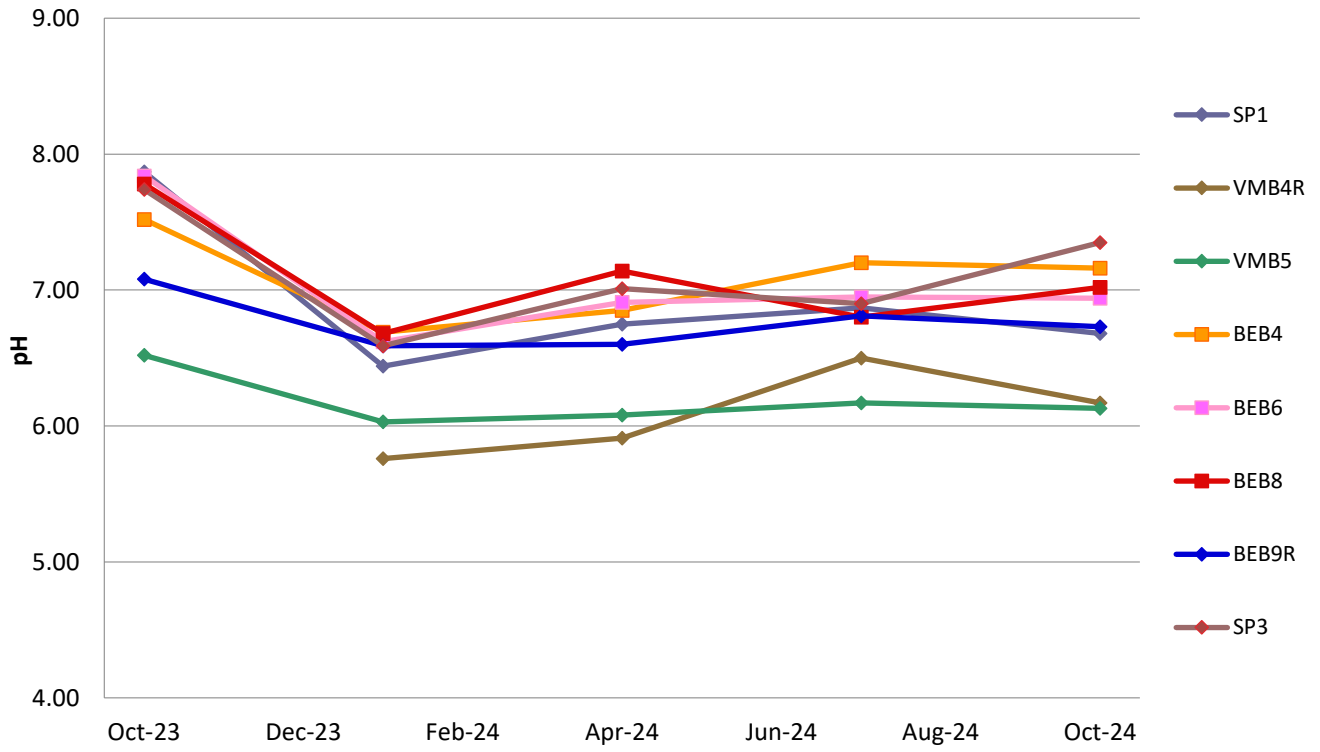
Figure 22 - BALLARAT EAST GW PH

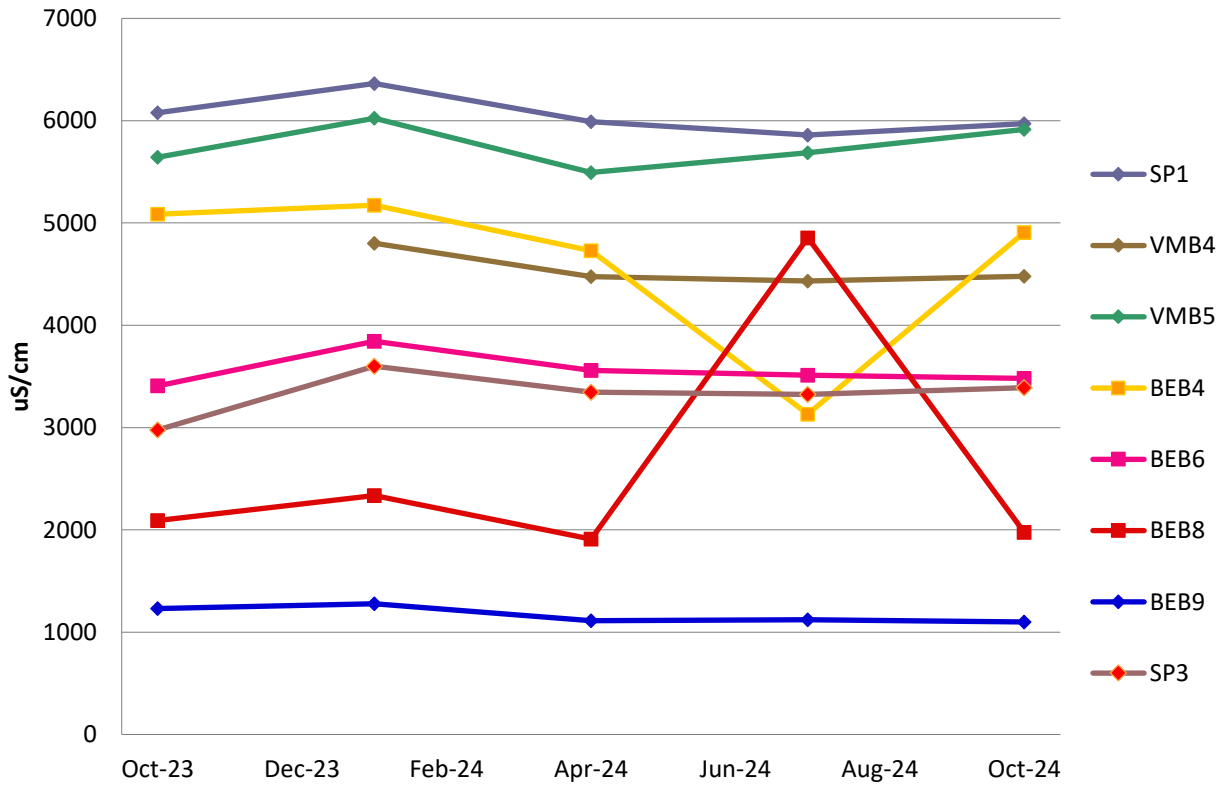
Figure 23 - BALLARAT EAST GW EC

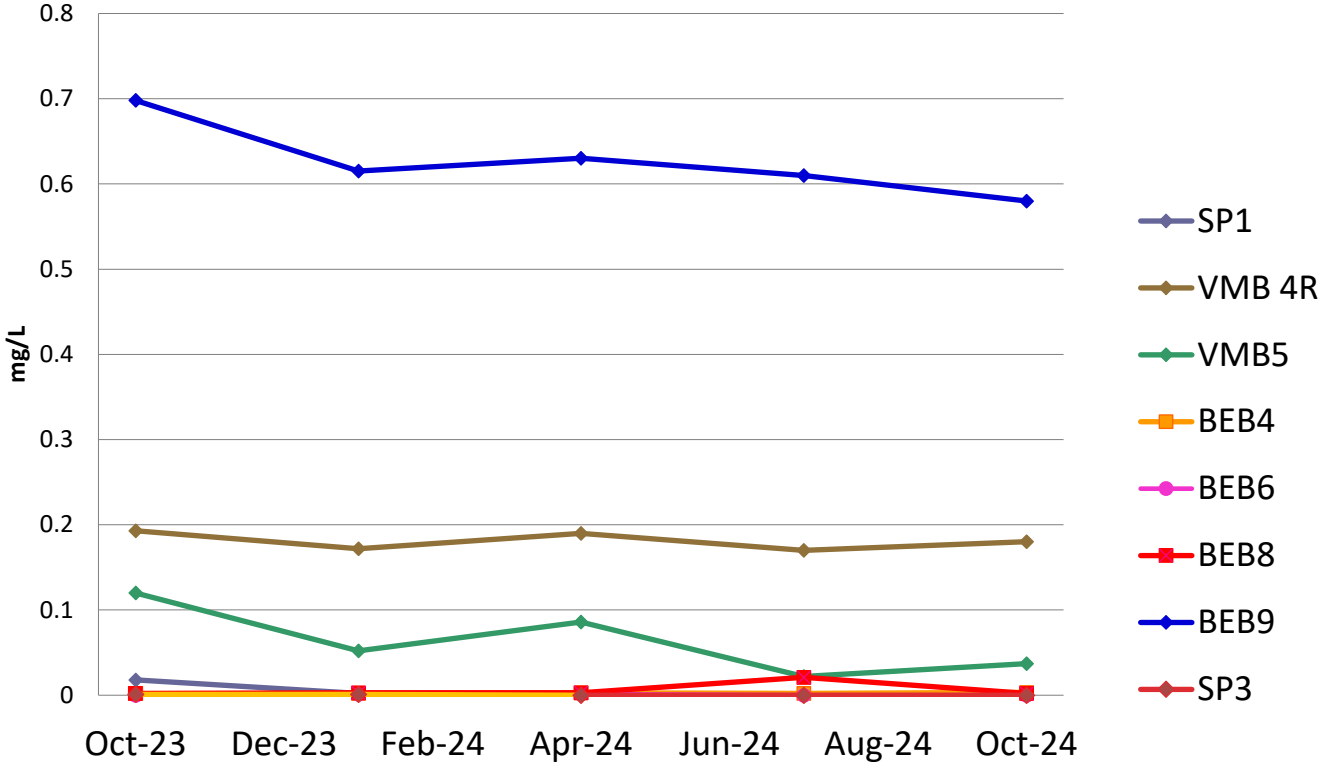
Figure 24 - BALLARAT EAST GW DISSOLVED AS LEVELS

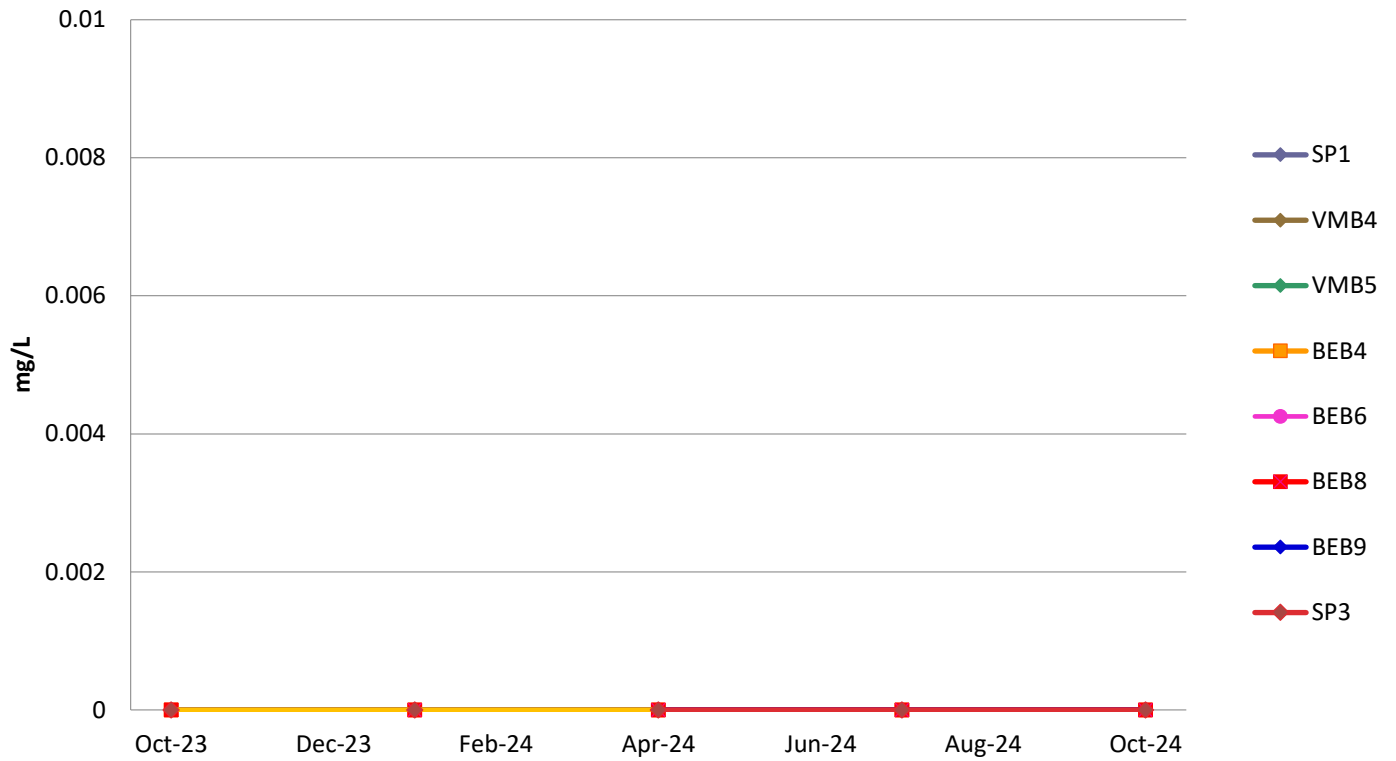
Figure 25 - BALLARAT EAST GW WAD CN LEVELS

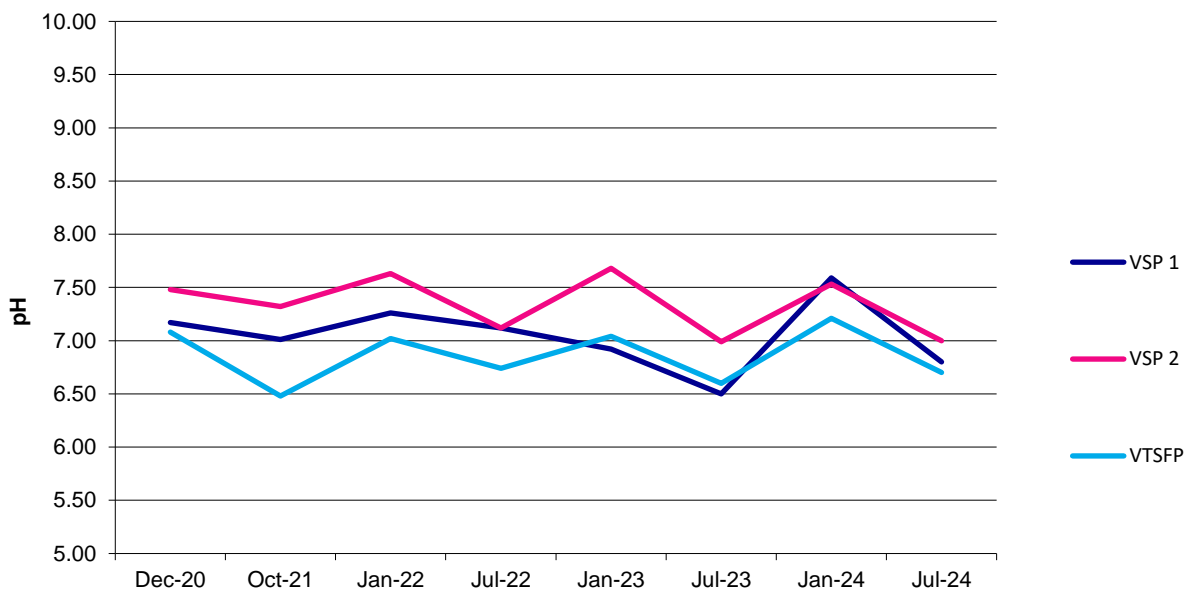
Figure 26 - BALLARAT SOUTH SW PH

Arsenic levels remain low and stable. pH levels have remained stable. WAD CN continues to return less than laboratory detection limits (0.004 mg/L) at all locations (Fig. 26-29)

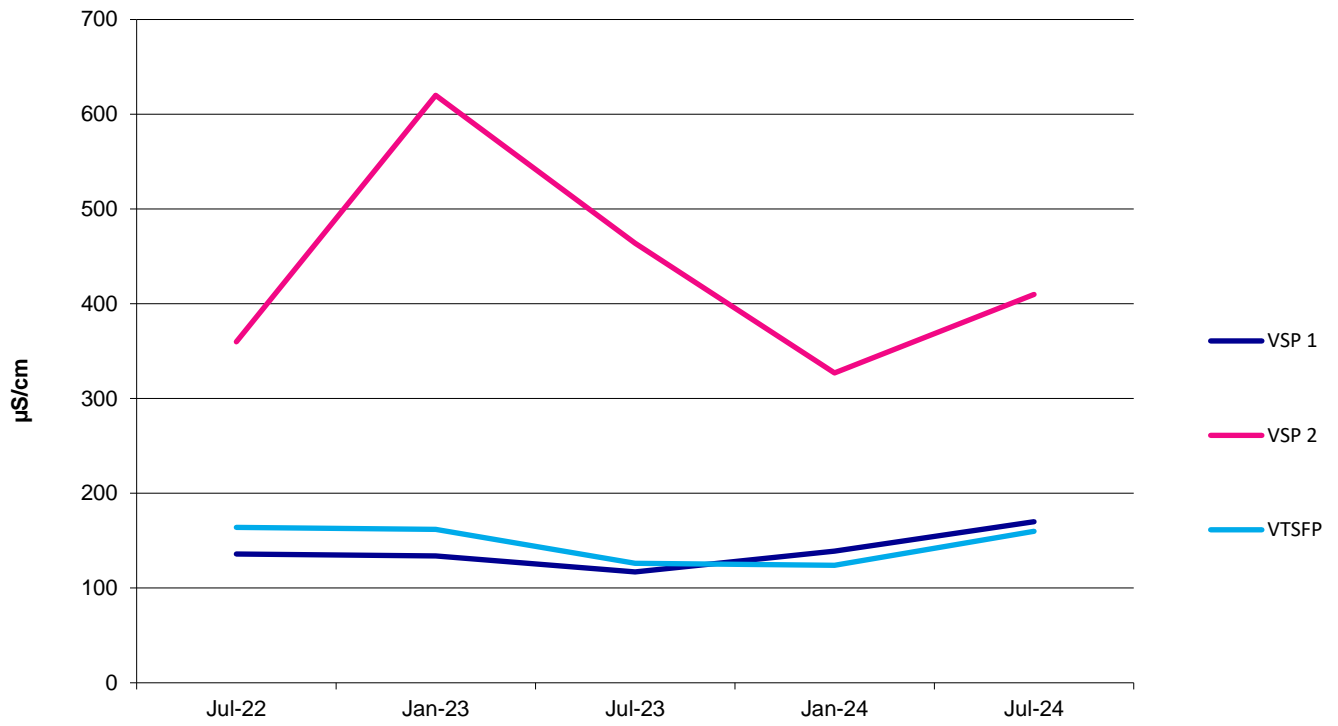
Figure 27 - BALLARAT SOUTH SW EC

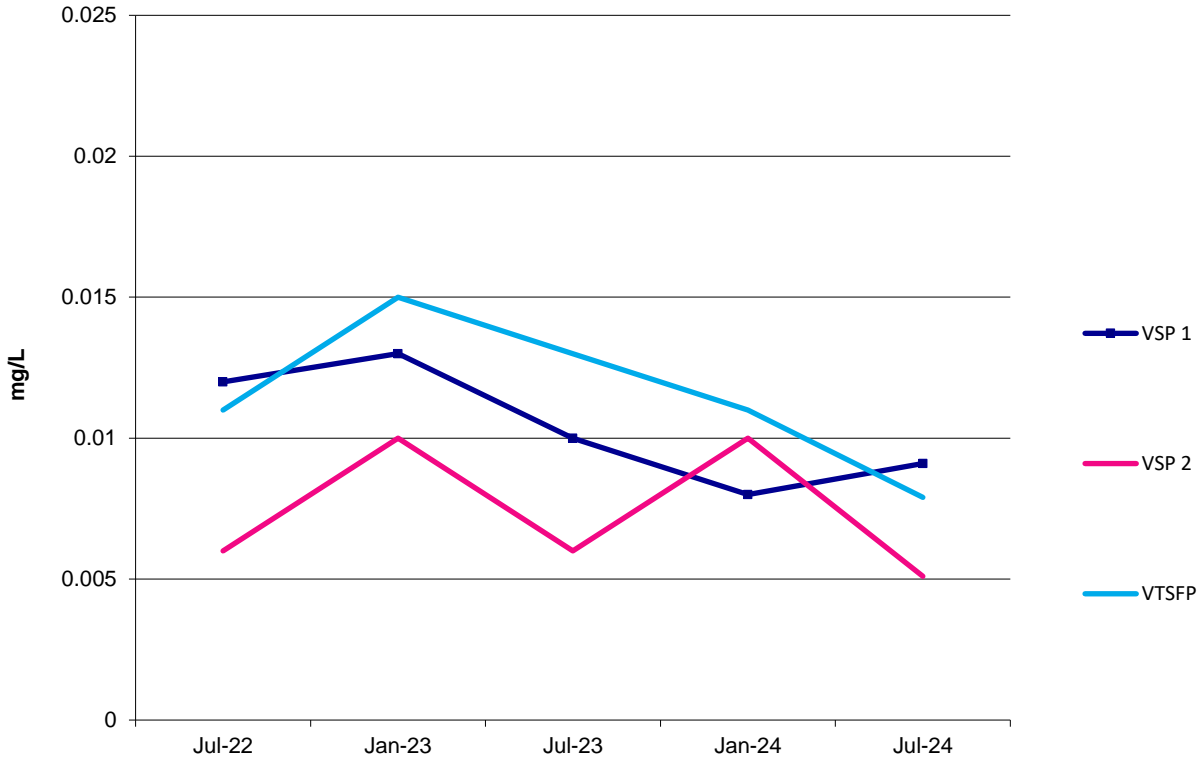
Figure 28 - BALLARAT SOUTH SW DISSOLVED ARSENIC LEVELS

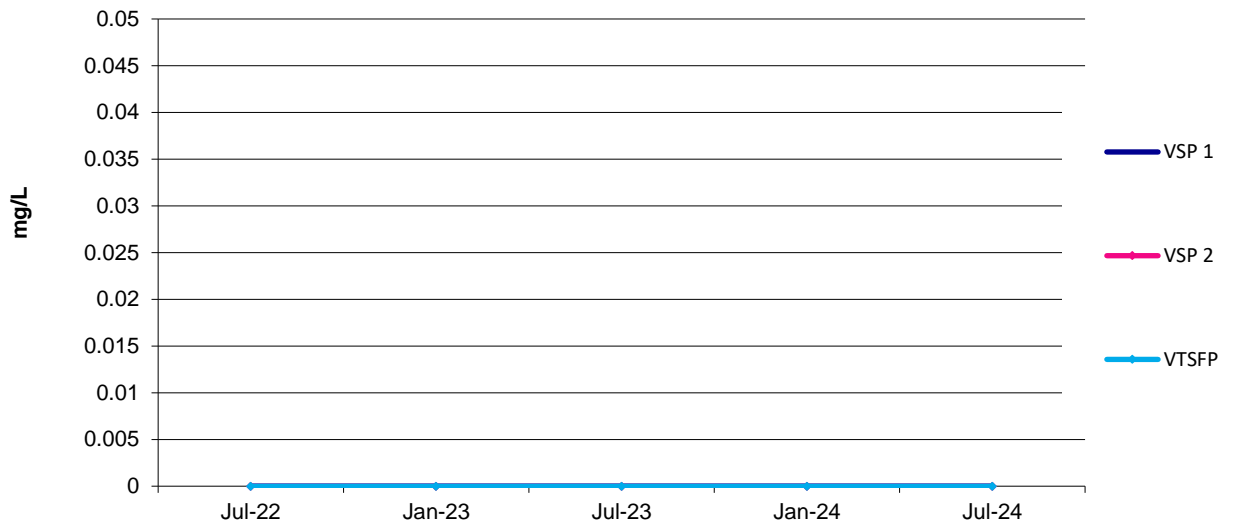
Figure 29 - BALLARAT SOUTH SW WAD CYANIDE LEVELS

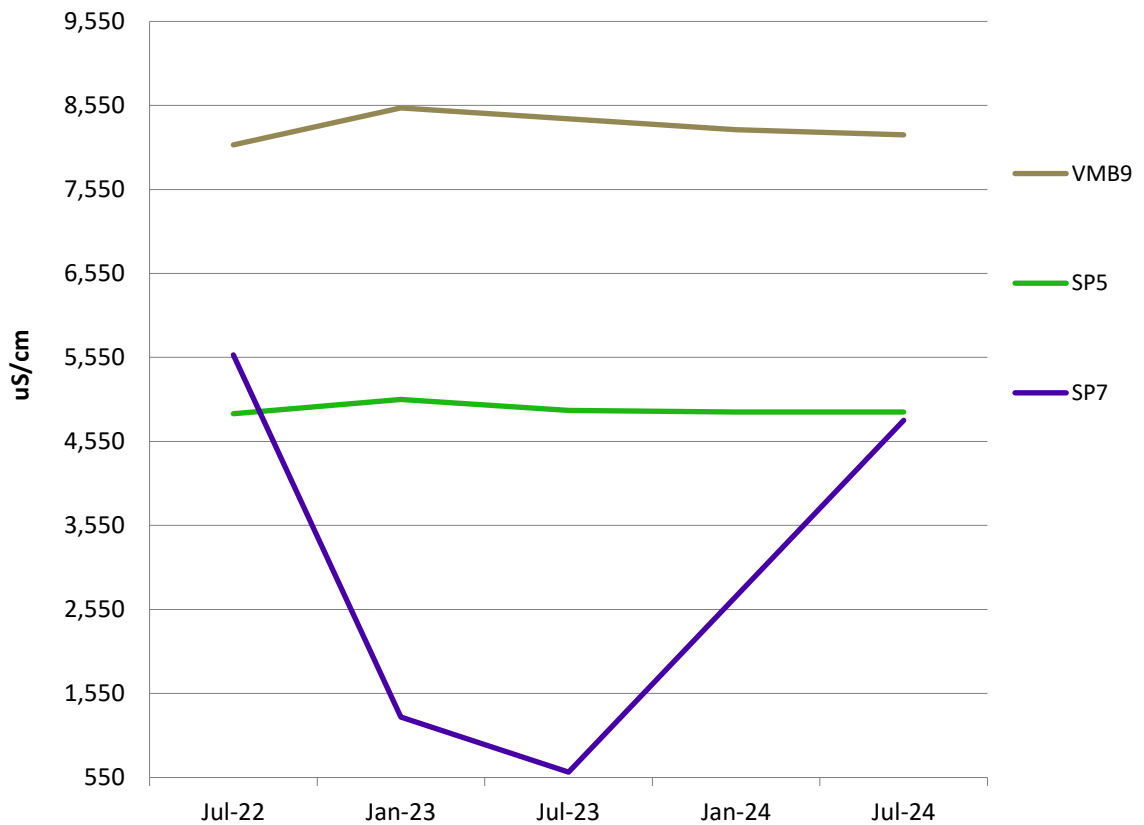
Figure 30 - BALLARAT SOUTH GW EC

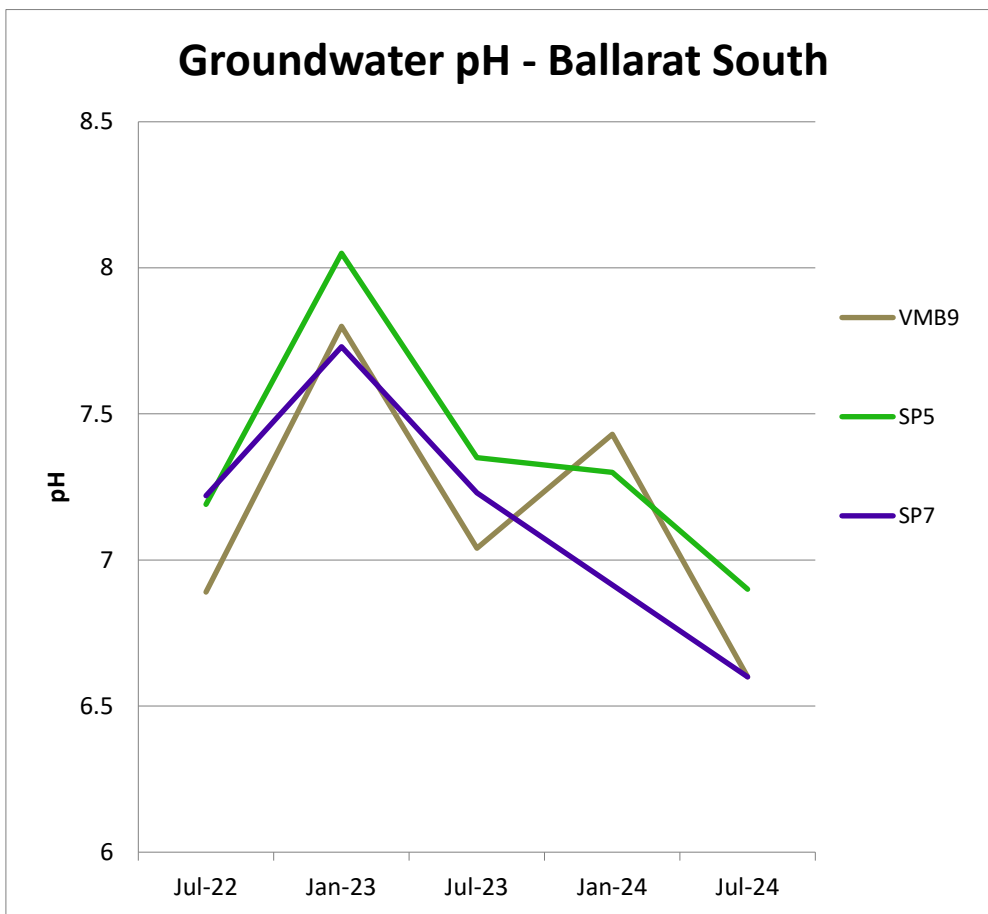
Figure 31 - BALLARAT SOUTH GW PH

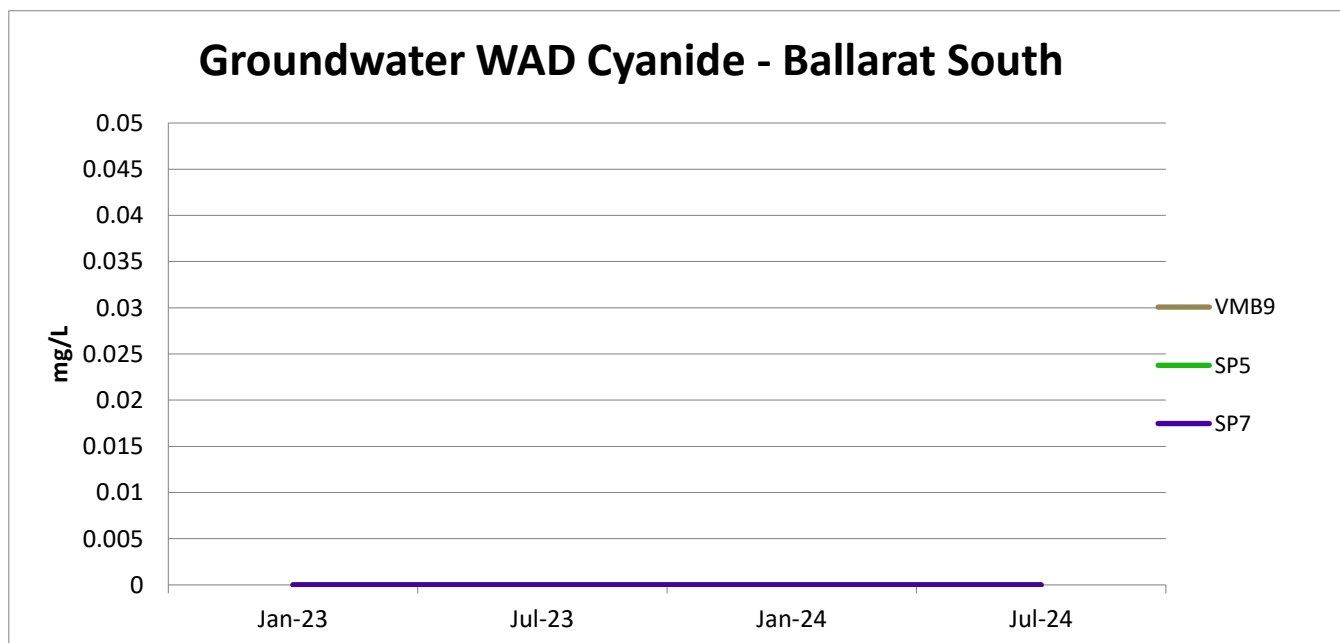
Figure 32 - Ballarat South GW WAD Cyanide

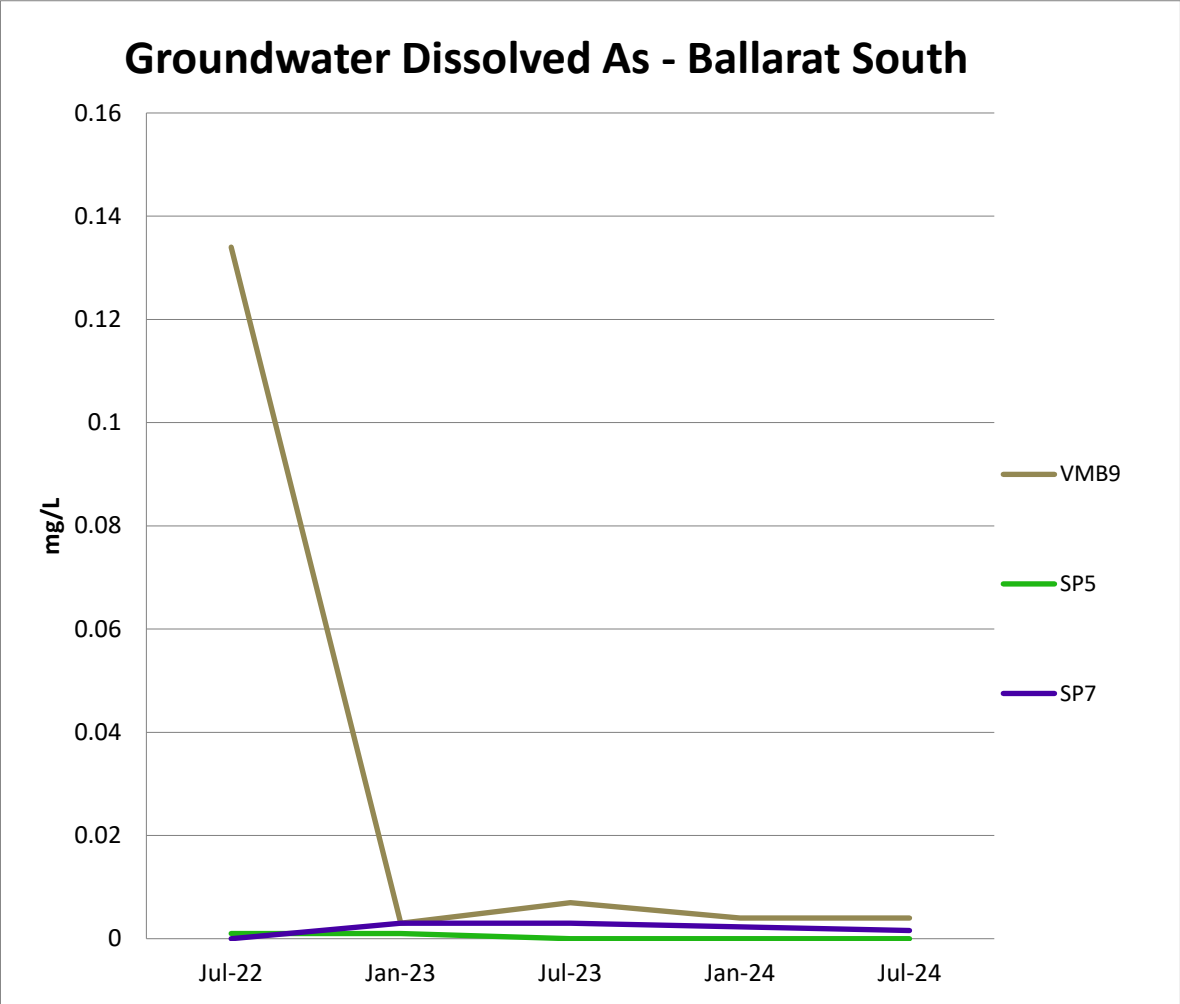
Figure 33 - BALLARAT SOUTH GW DISSOLVED AS

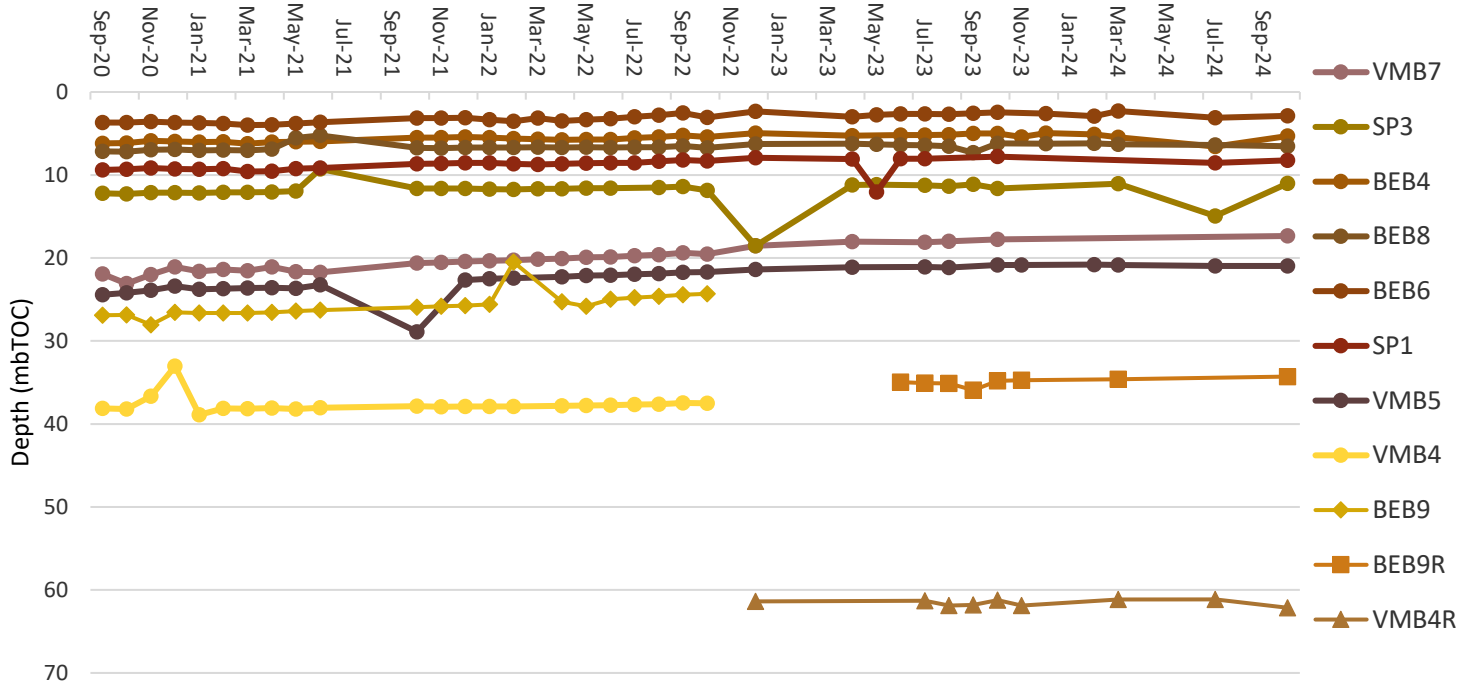
Figure 34 - Ground water levels Ballarat East

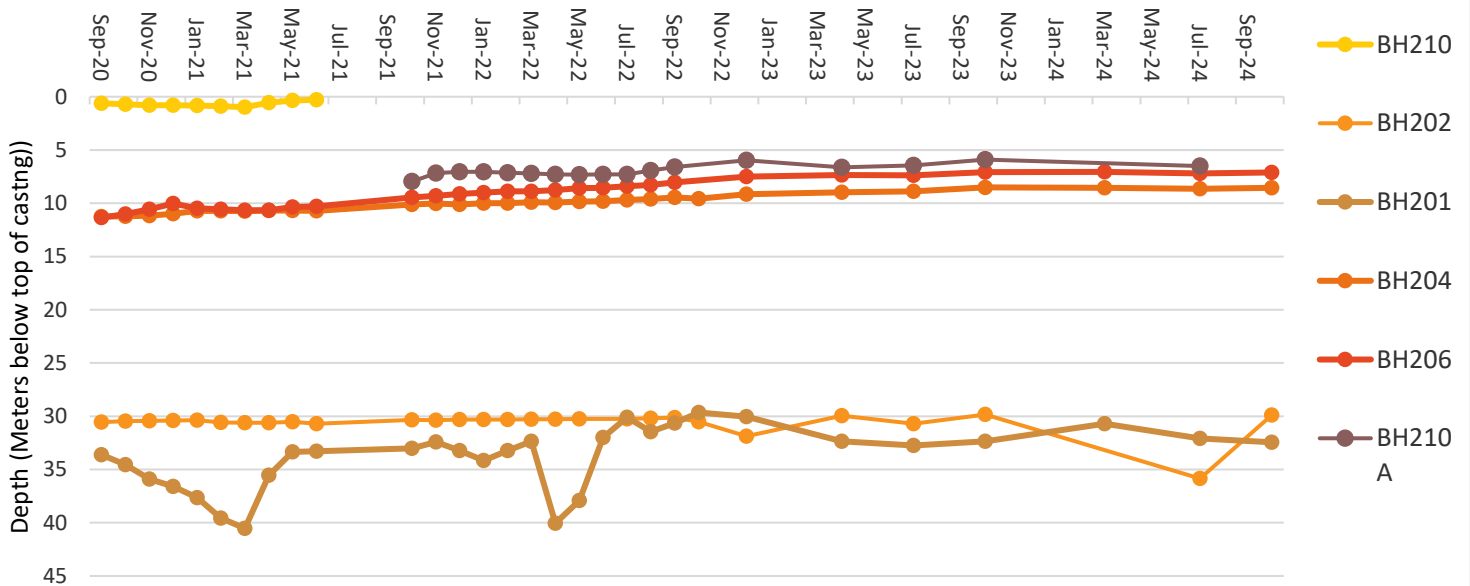
Figure 35 - Groundwater Levels within proposed TSF4 location.

The groundwater bores within Whitehorse Gully continue to be monitored on a quarterly basis to establish baseline concentrations, prior to the proposed construction of the new TSF4.

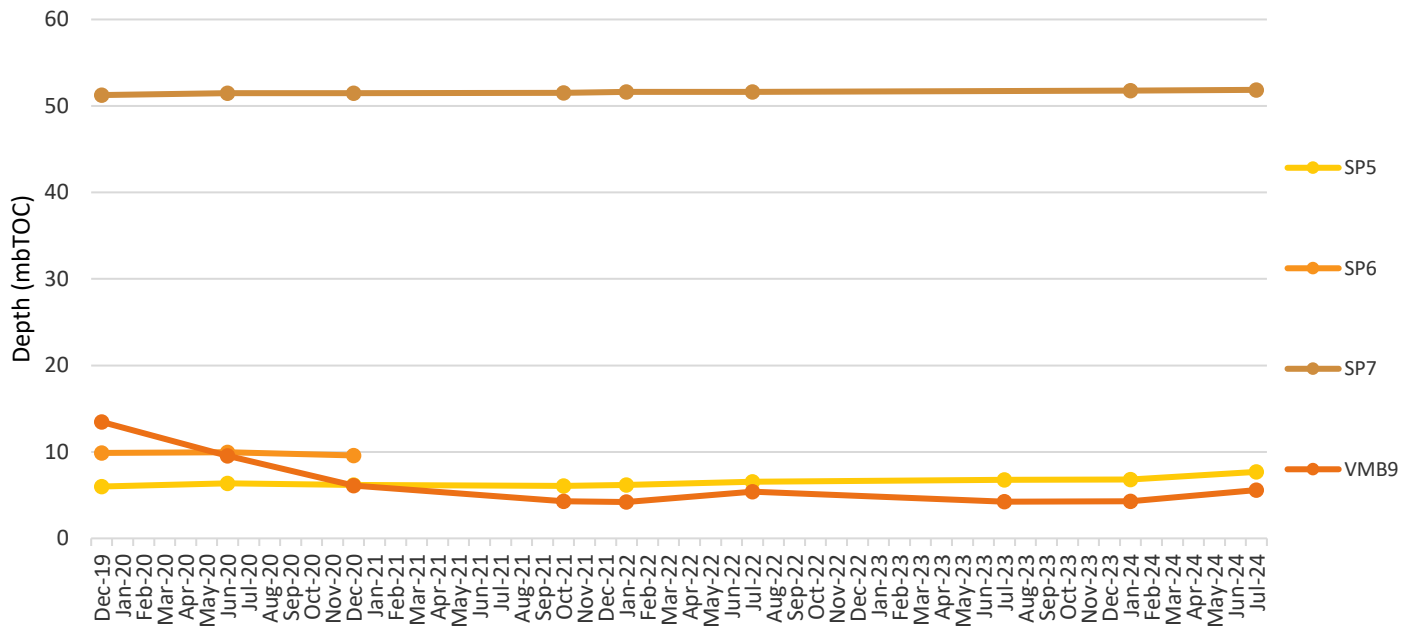
Figure 36 - GROUND WATER LEVELS AROUND THE BALLARAT EAST AND SOUTH
