Environmental Review Committee

Quarterly Report

No. 121

January – March 2025

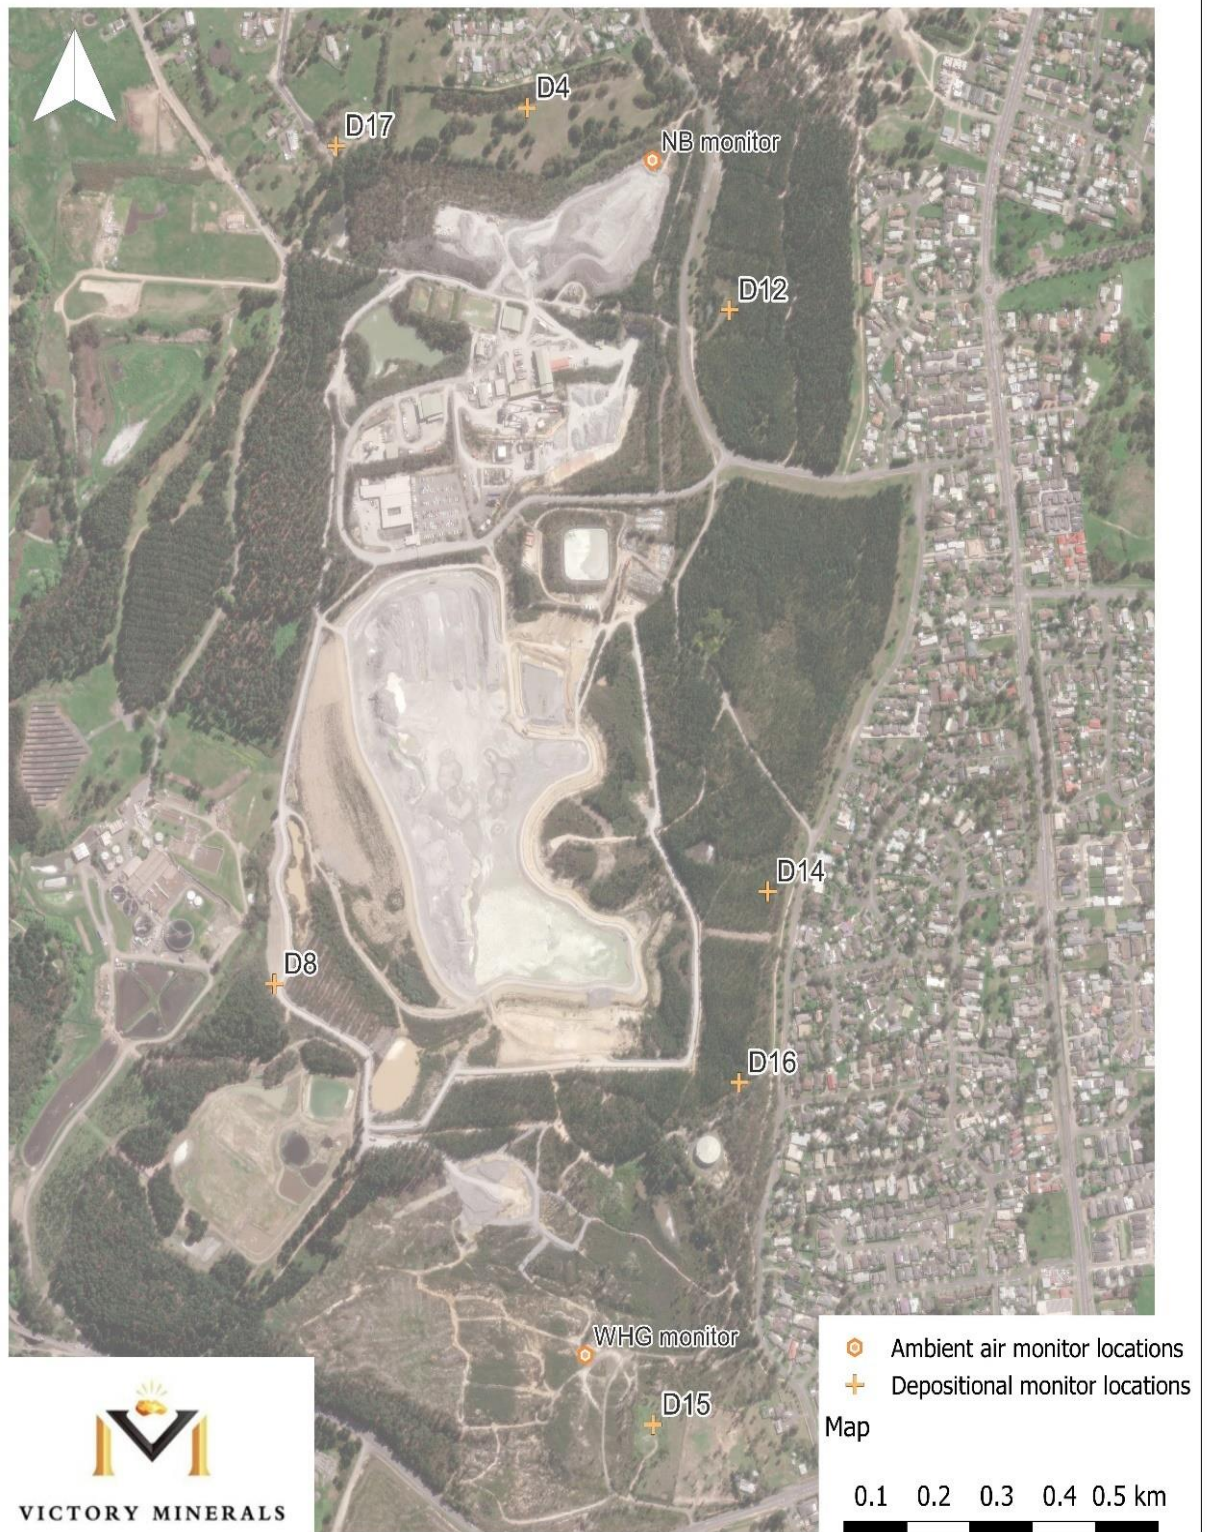
Figure 5 - MAP OF DUST MONITORING LOCATIONS

Monitor 1, is in place at White Horse Gully and Monitor 2, located at the northern end of the site Near to the Waste rock bund.

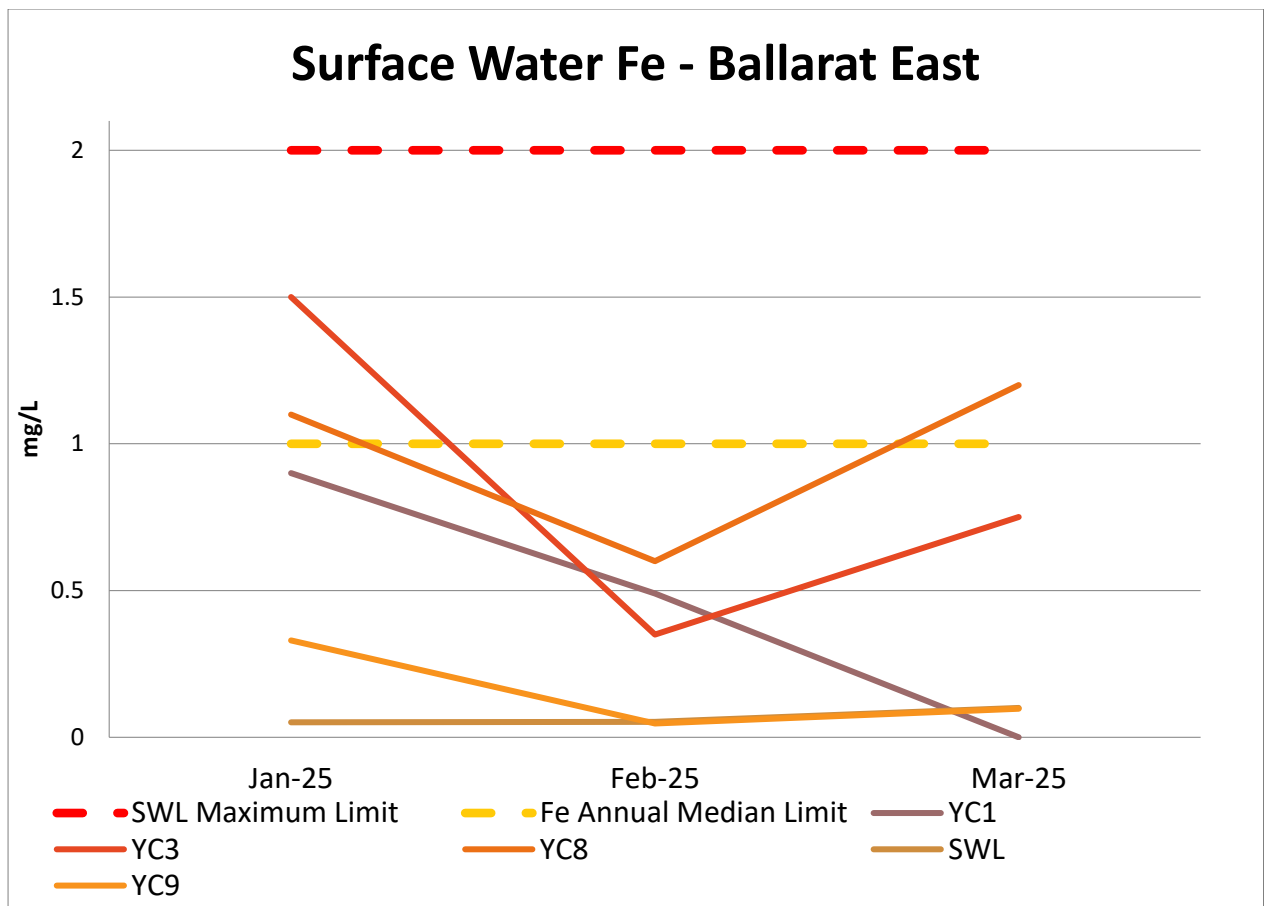
Figure 14 - IRON AT YC3 & YC8 (UPSTREAM), SWL (DISCHARGE POINT) AND YC9 (END OF MIXING ZONE)

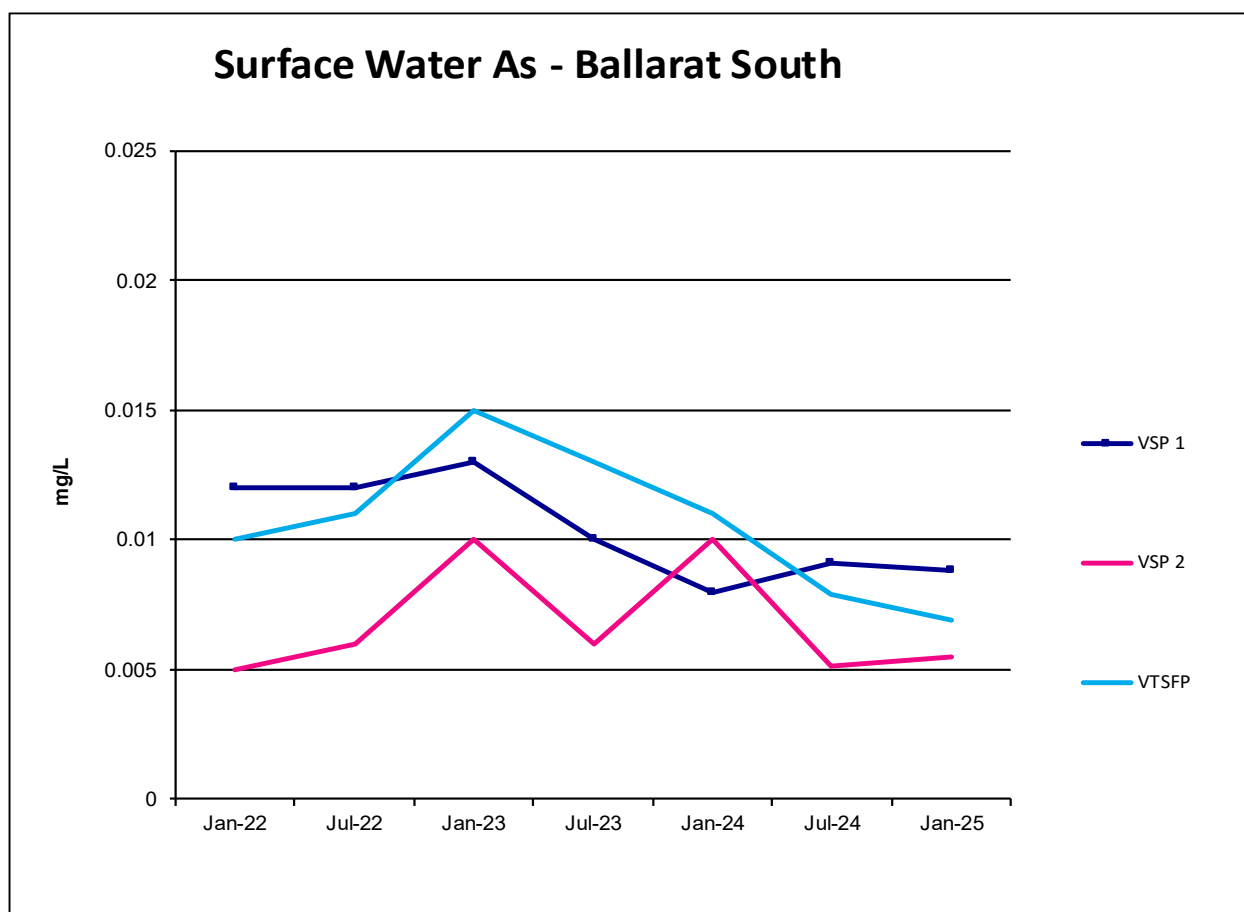
Figure 26 - BALLARAT SOUTH SW PH

Figure 27 - BALLARAT SOUTH SW EC

Figure 28 - BALLARAT SOUTH SW DISSOLVED ARSENIC LEVELS

Figure 29 - BALLARAT SOUTH SW WAD CYANIDE LEVELS

Arsenic levels remain low and stable. pH levels have remained stable. WAD CN continues to return less than laboratory detection limits (0.004 mg/L) at all locations (Fig. 26-29)

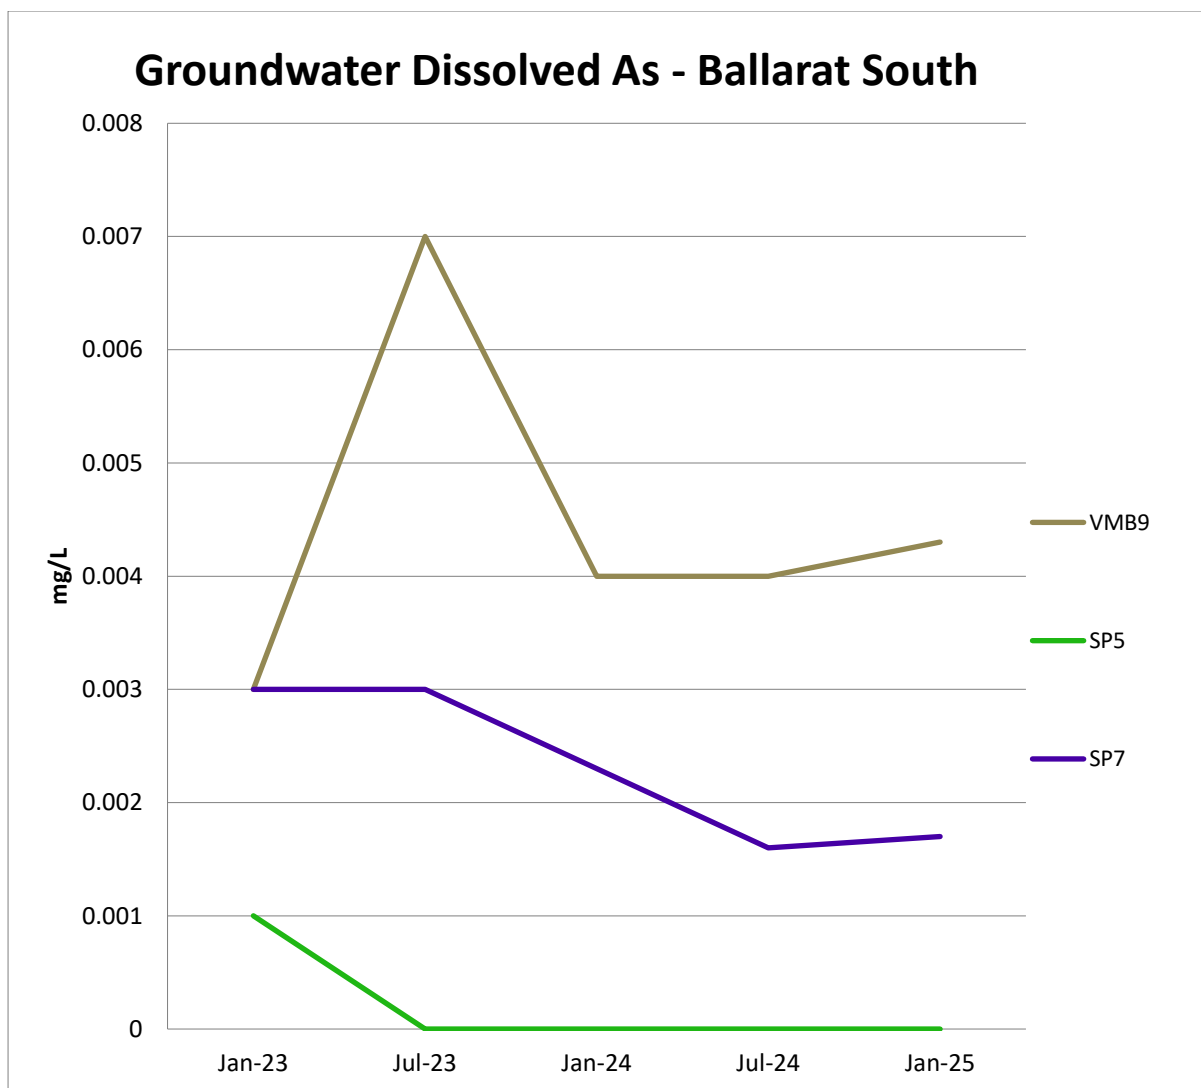
Figure 30 - BALLARAT SOUTH GW EC

Figure 31 - BALLARAT SOUTH GW PH

Figure 32 - Ballarat South GW WAD Cyanide

Figure 33 - BALLARAT SOUTH GW DISSOLVED AS

Ground water levels across the four bores are stable. Arsenic (As) levels remained relatively stable at SP5 and SP7. WAD CN returned less than laboratory detection limits (<0.004 mg/L) at all bores. (Fig. 20-34).

All results are within historic range at all groundwater bores. Electrical Conductivity (EC) across the monitored bores is again stable for SP5 and VMB9 and within their historic ranges. SP7 is back tracking similarly to SP5 relative to EC.
