## *Llanberris Rehabilitation Plan*

### **Setting**

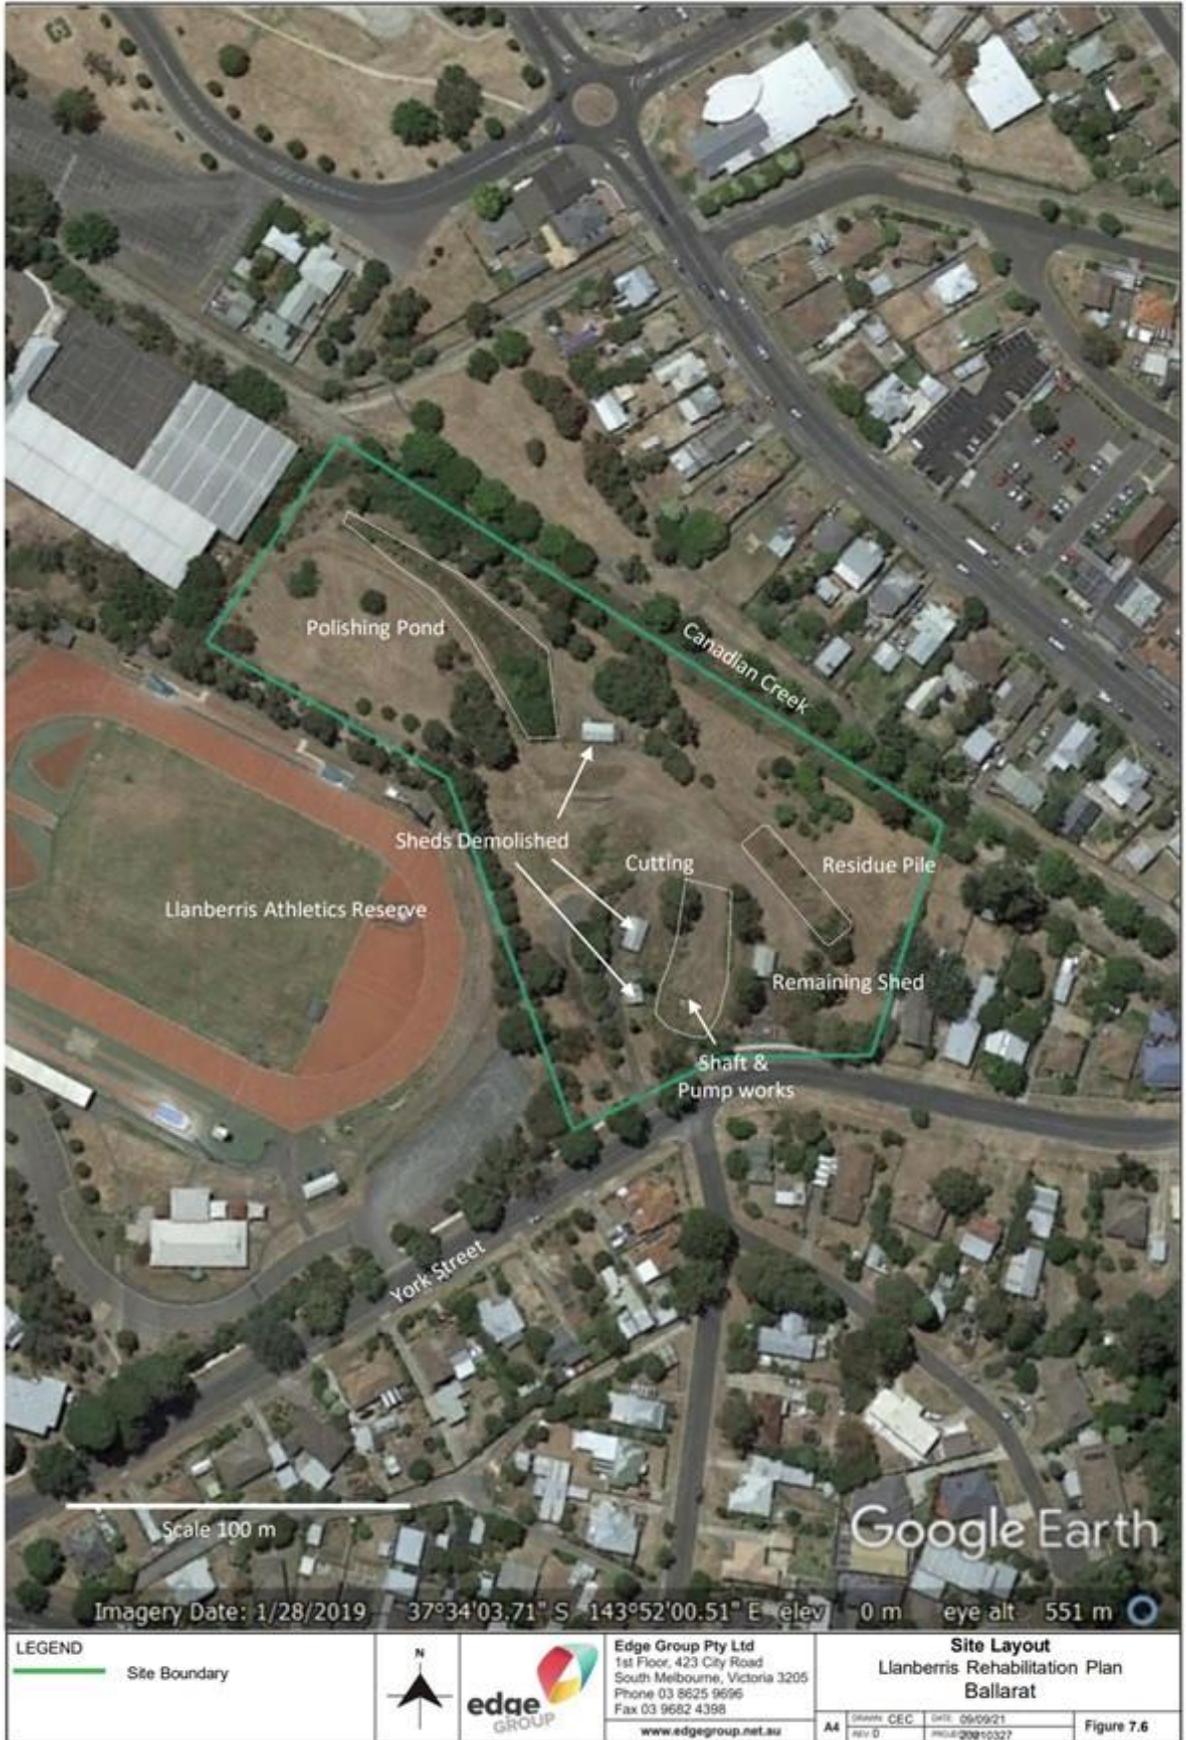
Figure 1 Llanberris Site Layout

The Llanberris site is in the suburb of Golden Point, Ballarat, and is within the Ballarat Mine Lease MIN5392. Figure 1 shows the lease boundary and the location of this site.

The site covers an area of approx. 1.9 Ha and is bounded by the Llanberris Athletics reserve to the west, Canadian Creek to the north-east, residential properties to the east and York Street to the south. The site slopes from the western boundary down to Canadian Creek, an elevation change of approx. 7m over 70-100m.

A trapezoidal shaped cutting into the southern, high side, of the site is the location of the original Llanberris shaft and more recently the dewatering point for the historic mine workings that enabled the current mine to commence mining deeper ore. All buildings apart from one have been removed from earlier operation of a plant that treated mine water before discharge to Canadian Creek. Several concrete pads and structures remain, along with some pumping headworks and piping.

A pile of sandy-grit residue approx. 25 m x 5 m x 1m in size is located north of the shaft. Samples from April 2021 show that it has elevated concentrations of arsenic.

A shallow oblong pond approx. 95 m length and ranging from 5 m to 15 m wide is in the north-west portion of the site. This was used as a polishing pond for the original water treatment plant. The overflow from the pond discharges to Canadian Creek.
