## **Otway Street**

### **Setting**

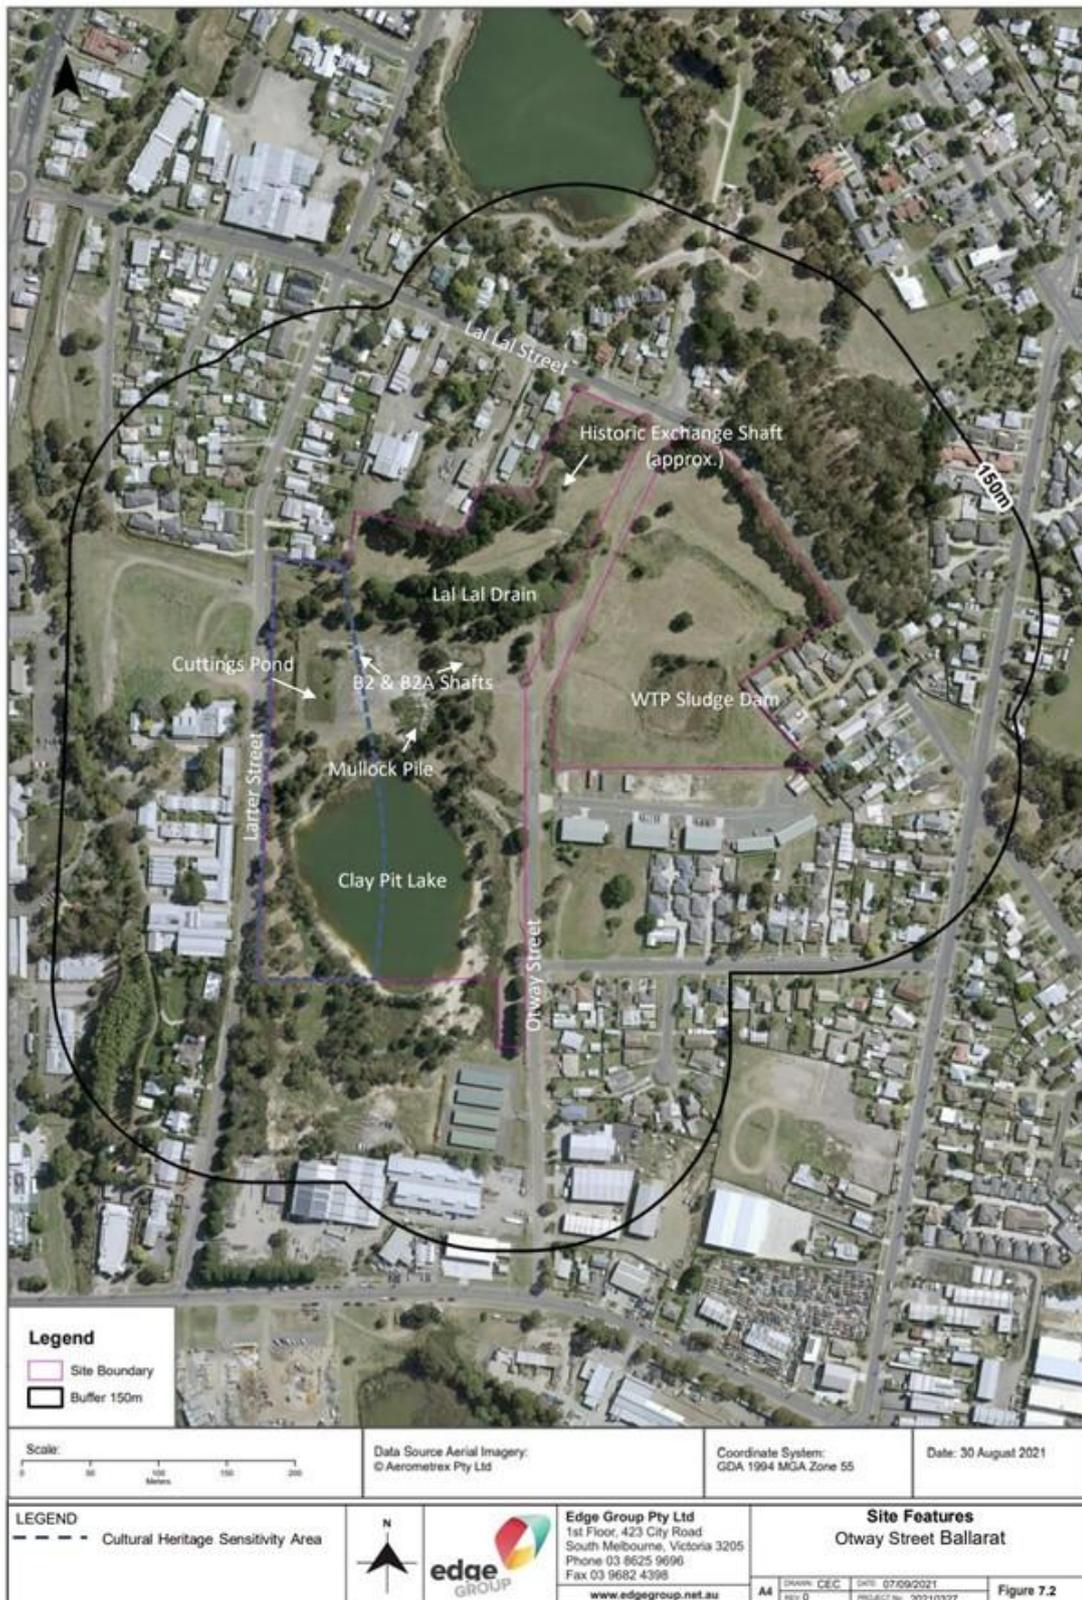
Figure 1 Site Layout

This site covers an area of approximately 10.4Ha bounded by Larter St to the west, residential and light industrial properties to the north, Lal Lal St to the northeast, mixed residential and light industrial to the east and southeast. The property titles show the site is split, in a north-south orientation, by a road alignment, the continuation of Otway Street. This road has not been constructed. The key features of the site are shown in Figure 1.

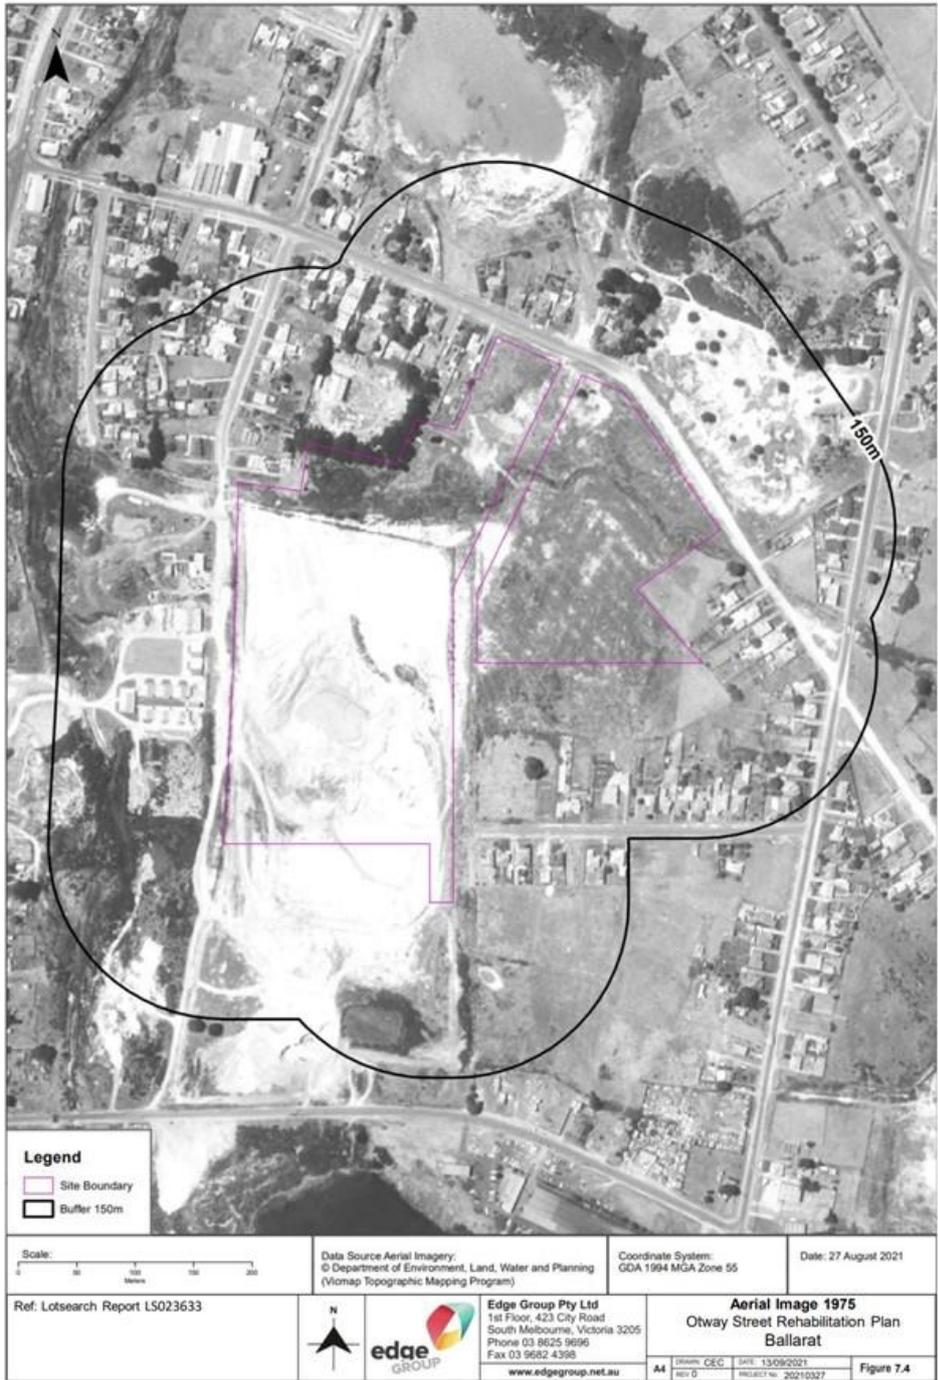
Figure 2 Image 1975

Figures 2 and 3 show the transition over the period from 1975 to 1990, that is prior to the construction of the shafts and when construction was underway.
